# THERMO-WRAP™

## FLARE LINE PIPING REHABILITATION

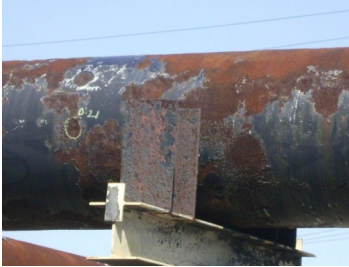
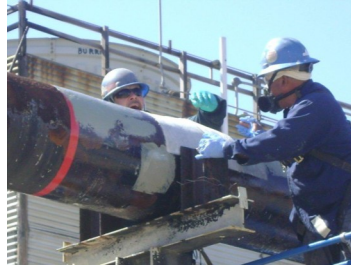
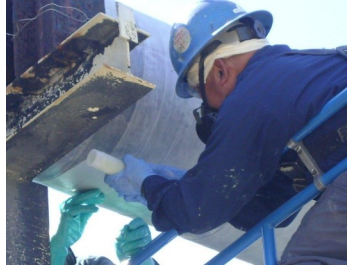
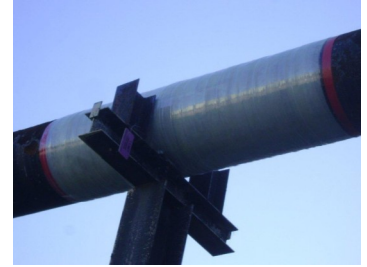
Scattered corrosion and pitting was found on this 24" OD flare line over a 300' section. UT readings were taken on the API Class 2 piping in conjunction with pit gauge measurements to determine remaining wall thickness. In several locations, the remaining wall thickness exceeded the corrosion allowance requiring immediate reinforcement. Over thirty eight areas of localized corrosion were identified over a 300' section of flare pipe. The size of the corrosion clusters ranged from 3/4" to 6" in diameter at a depth of 40% to 80% of the original wall thickness.

There was a concern that if aggressive surface preparation methods on the top 1/3 of the pipe it would open thru wall holes in the flare line causing unsafe working conditions or resulting in a facility shutdown. Due to this concern, surface preparation techniques were specified, based on the condition of the top and the bottom of the pipe. Electric powered tools could not be used as they may have presented an ignition source and a fire hazard.

The surface preparation was applied in 20 to 40' sections since the repair would encompass several hundred feet of repair. The bottom 2/3 of the pipe was prepared in accordance with SP10 using high-pressure 3,000 to 7,000 psi (206.84 to 482.63 bar) water blasting while the top 1/3 of pipe was prepared in accordance with SP1, SP2 (hand tools) around pits using sandpaper. All pits were filled and the original pipe geometry was reformed using Syntho-Poxy™HC, a high compression strength (18,000 psi), load transferring filler epoxy. Five to ten mils of a 2-part epoxy, Thermo-Poxy™, was then applied to the surface to promote bond and prevent corrosion. The sections of pipe were then wrapped with 4-layers of the Thermo-Wrap™ system, a 100,000 psi (6,895 bar) tensile strength fiberglass wrap system, which provides structural integrity to the thinned pipe.

NRI was able to fix the thinned and pitted flare line and restore it to higher than its original design pressure. By utilizing the Thermo-Wrap composite repair system, the pipe could remain in full working operation without the need to reduce the temperature or pressure, thereby fully repairing and reinforcing the section, while maintaining the current production schedules.
