SYNTHO-GLOSS[®] XT

UTILITY FIELD INSTALLATION: STEEL REINFORCED CONCRETE

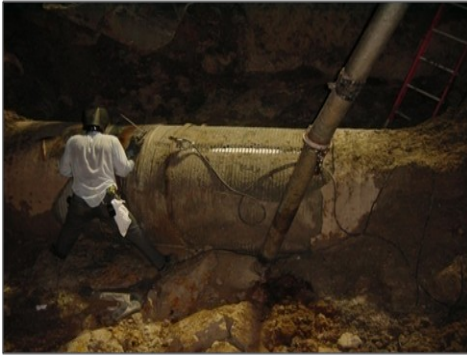
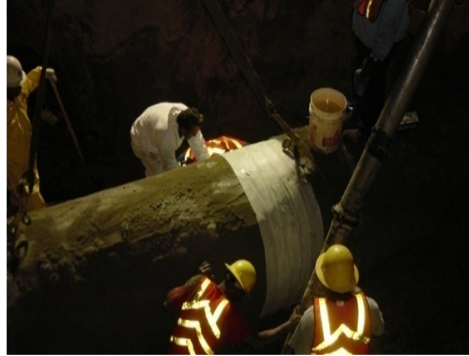
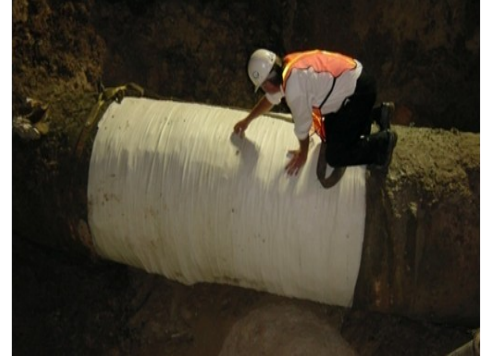
A 20 year old pre-stressed concrete pipe is leaking large amounts of hydrogen sulfide gas, liquefying to sulfuric acid, causing pipe deterioration.

Sewage is percolating through the ruptured municipal force main which is buried 8 feet underground. Sulfuric acid has eaten through 2 feet of the pipe's crown.

The crew used an 8" by 50' roll of Syntho-Glass[®]XT to wrap 8 layers over the 2' repair section, plus an additional 4 to 5 feet on either side of the patch, as a precautionary measure.

The wrapped area of the pipe is now as strong, or stronger, than the original pipe and allowed the city to save thousands of dollars, as compared to traditional repairs with couplings and forced main shutdown.
