SYNTHO-GLASS[®] XT

16" TO 20" OD TEE

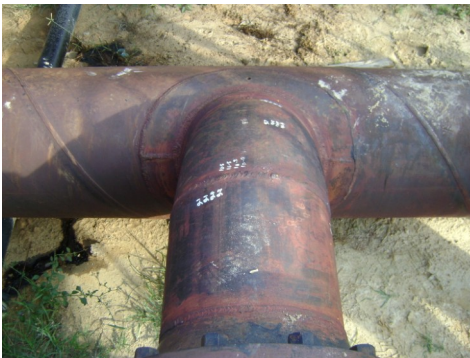
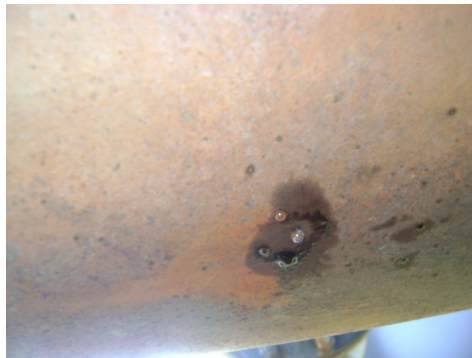
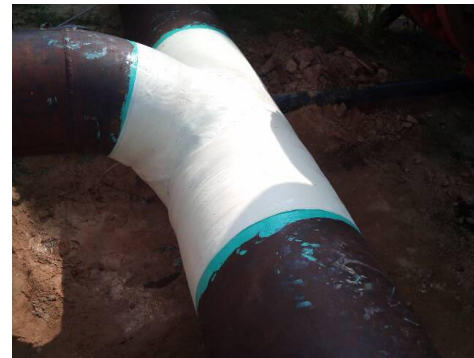
A 20" OD carbon steel pipe in a refinery in Indonesia is leaking at the 6 o'clock position and connected with a 16" OD tee, to make sealing this leak more difficult.

Through wall leaks by internal corrosion located in various areas.

In order to promote adhesion, the pipe was cleaned by removing rust, paint, and other foreign matter in accordance with Sa2.5, NACE 2, or near white metal. Syntho-Steel[™] was used as the initial leak stopping material, followed by a coating around the leaking area of Syntho-Poxy[™] HC to fill all pits and other anomalies, effectively transferring the hoop load to the high tensile strength composite. Syntho-SubSea[™] LV epoxy ensures a water tight seal over the repair area while also providing chemical resistance. Syntho-Glass[®] XT, a high strength, bi-directional fiberglass composite, repairs and reinforces both the internal and external corrosion damage effectively creating a new "pipe section" of reinforcement. This system enabled the difficult to repair geometry of pipe in quick and efficient manner while still allowing full encapsulation of the damage tee.
