SYNTHO-GLASS[®] XT

46" OD PROCESS WATER LINE

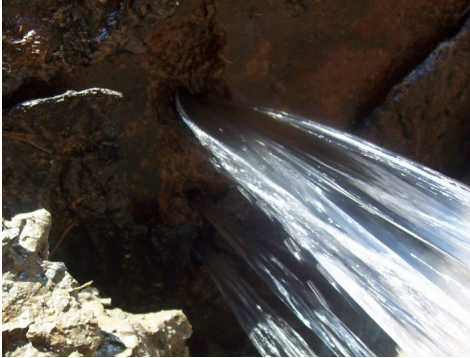
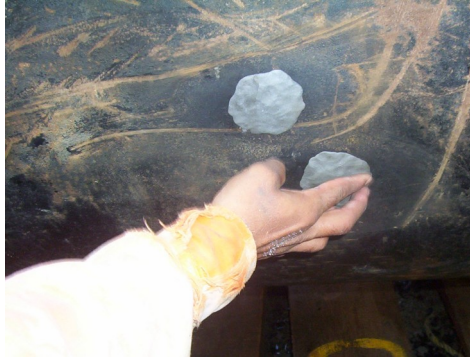
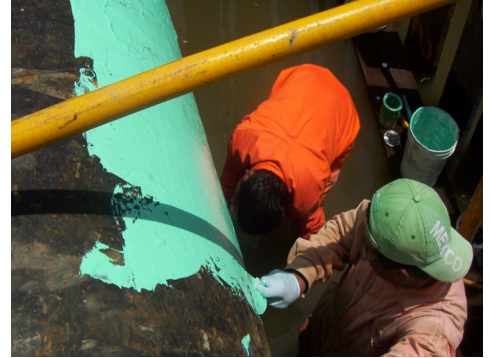
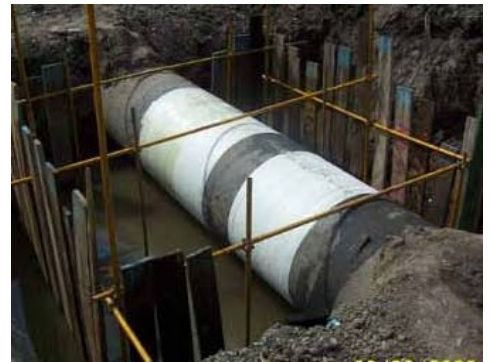
A 30 psi (2.07 bar), 46" OD process water line is leaking and in need of immediate repair.

Through wall leaks and cracks caused by internal and external corrosion.

In order to promote adhesion, the pipe was cleaned by removing rust, paint, and other foreign matter in accordance with Sa2.5, NACE 2 or near white metal. Syntho-Steel[™] Load Transfer Putty fills all pits, dents, and other anomalies, effectively transferring the hoop load to the high tensile strength composite. Syntho-SubSea[™]LV High Compression Kelvar[®] filled Epoxy ensures a water tight seal over the repair area while providing chemical resistance. Syntho-Glass[®] XT Extreme Tensile Strength Composite, a bi-directional fiberglass, permanently repairs and reinforces both the internal and external corrosion damage.

The composite repair system eliminated the need to immediately replace the line. The repair was completed inexpensively in a matter of hours. Syntho-Glass XT fully restored the pipe's hoop and axial strength to enable operation at full MAOP.
