SYNTHO-GLOSS®XT

PIPELINE INSTALLATION: GATE VALVE

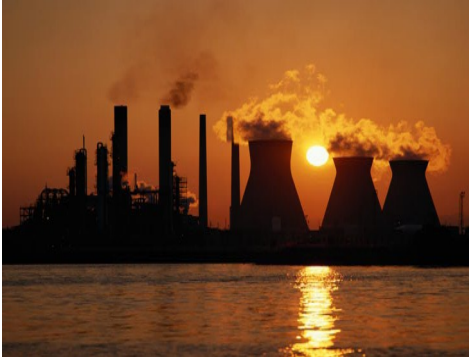
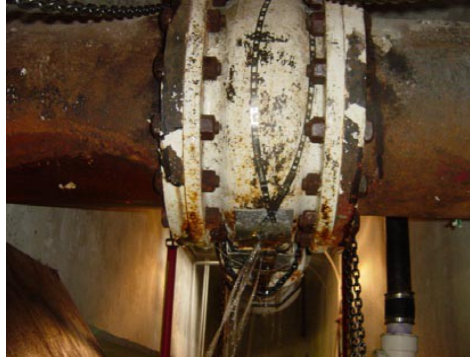
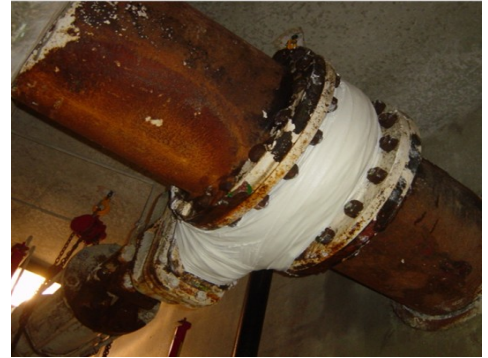
The gate valve coupling is showing major distress areas and leakage and on the verge of a catastrophic breakdown.

The gate valve is suffering from major corrosion and wall loss. Several pinhole size leaks have already begun to form, making the impending repair even more critical.

In order to promote adhesion, the pipe was cleaned by removing rust, paint, and other foreign matter in accordance with Sa2.5, NACE 2 or near white metal. It was then coated with a two part Syntho-Subsea™ Kevlar® reinforced epoxy. The two part epoxy halted the corrosion and ensured a water tight seal. The valve was then wrapped with multiple layers of Syntho-Glass®XT which provides structural integrity to the repair system.

The repair was an immediate success, as the gate valve now has even more strength than the original pipe and valve at the time of installation. The valve once again meets the MAOP and is also protected from further corrosion.
