SYNTHO-GLASS[®] XT

PIPELINE INSTALLATION: HEAT EXCHANGER REINFORCEMENT AND REPAIR

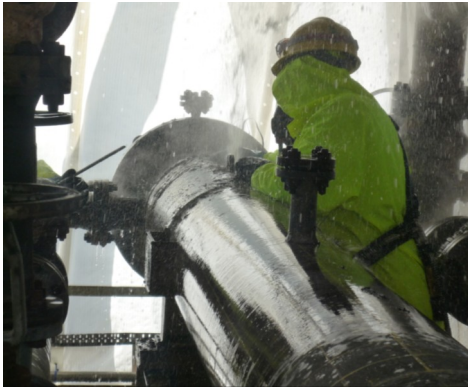
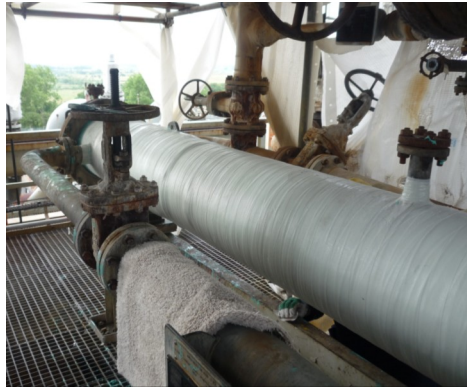
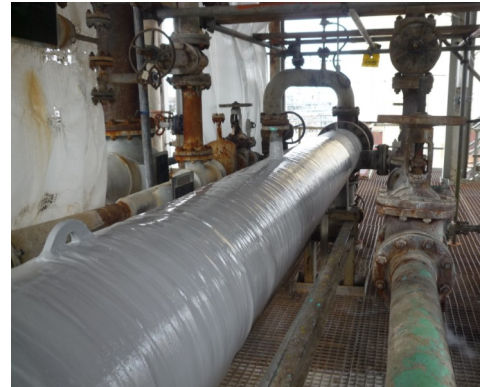
Previous competitors patches on this heat exchanger had failed in several locations, were leaking and in need of immediate repair. A long term shutdown was not an option, therefore the repair had to be completed while the system was operational.

The composite calculations were based on a design pressure of 76 psi (5.2 bar) for the API 5L GrB exchanger pipe with an original wall thickness of 0.375" (9.5mm) which was inspected to have a minimum remaining wall thickness of 0" (0mm) leaking.

NRI recommended that a leak check be performed to identify each leak's point of origin prior to starting the repair. After each leak was identified and labeled on the pipe, the repair area was hand sanded and a rounded file was used to create an X-profile pattern on the surface of the pipe around the edge of each leak point since sandblasters could not be used to create the recommended Sa 2.5 or NACE 2 SSPC 0.5mm-1mm anchor pattern. Once surface prep was completed Syntho-Steel[™], a 2-part epoxy putty stick, was used to seal each leak by forcing it into the source of each leak using a pressure sealing straps to overcome the 76 psi of pressure. Once all leaks were sealed, the pressure straps were removed and a leak test "hold point" was performed. After passing the leak test, additional surface preparation was completed over the entire pipe. All pits, patch seams and other anomalies were filled, profiled and covered using Syntho-Poxy HC to match the contour of the outside diameter of the pipe providing a secondary pressure sealing barrier over the primary leak patches. Once the Syntho-Poxy fully cured, a second leak test "hold point" was performed to reconfirm that each leak was sealed prior to applying the Syntho-SubSea[™]LV, a water displacement load transferring 2-part Kevlar[®] reinforced epoxy. The SubSea LV epoxy was applied at 30mils (0.76cm-1.5cm) around the entire circumference of the heat exchanger, extending the coverage over the entire composite repair length of 197" (5004mm) providing a third pressure sealing barrier over the primary leak patches. Eight layers of Syntho-Glass[®]XT, a 54,000 tensile/hoop strength E-glass composite sleeve were applied over 197" (5004mm) to add hoop strength over the leak patches and rehabilitate the structural integrity of the defective areas of stressed pipe on the heat exchanger pipe.

The composite repair system was engineered to arrest the leaks while providing the structural strength to meet the design pressure of 76 psi (5.2 bar) for a minimum of 2 months, thus preventing the refinery from experiencing an unexpected shutdown of the heat exchanger.
