Reliability and Maintenance Conference  
May 22-25, 2012  
Henry B. Gonzales Convention Center  
San Antonio, TX

RMC-12-29

**USING NON-METALLIC COMPOSITE  
MATERIAL FOR HIGH  
TEMPERATURE PIPING REPAIRS**

Matthew A. Green  
Christopher J. Lazzara  
Neptune Research, Inc.  
Lake Park, FL

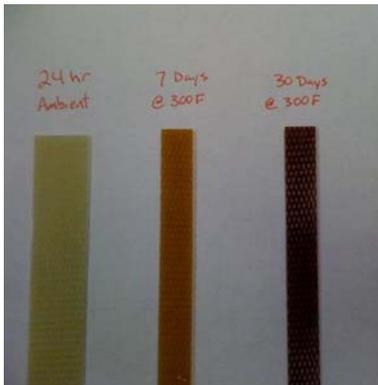
It should be noted that as the epoxy was "aged" in the high temperature environment, it underwent a color change. This phenomenon is normal and expected as a general characteristic of the system. It should also be noted that the observation was made that the ingress of the color change was limited to the outer edges of the coupons and the interior of the coupon did not seem to be affected, even after the prolonged submersion in the high temperature environment. This leads to a hypothesis that the material has some insulating qualities which protect a large portion of the interior strength of the system. This seems

Figure 6: Color change of composite over time under temperature

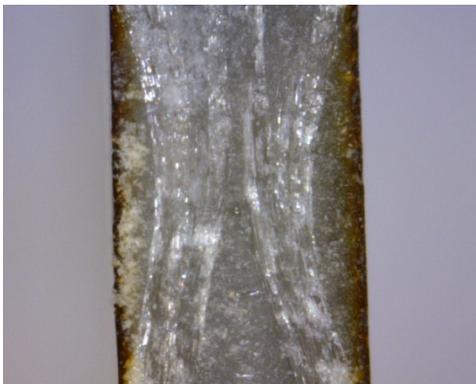
Figure 7: Coupon at 30 days of 300 F with limited color change ingress on coupon

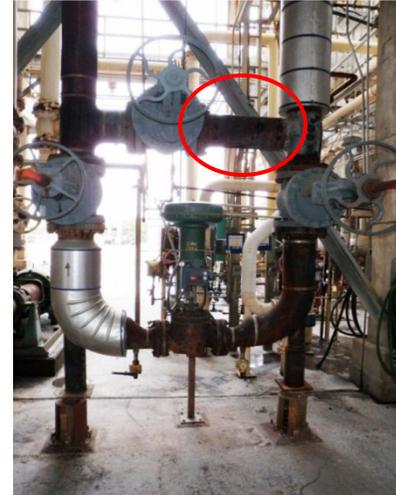
During a routine inspection of process pipelines using Ultrasonic testing, thin spots were discovered on a DMV bypass line in the Sour Crude Unit. The system with the thin spots consisted of a 10" Sch. 40 API 5L Gr. B pipe with an original wall thickness of 0.365". Inspection of the pipe recorded readings of up to 0.19" remaining thickness, representing an internal wall loss of almost 50%. The product carried in the pipe was top pump around fluid consisting mainly of heavy naphtha and kerosene. The line operates at around 270° F and 215 psi during normal operating conditions, with a design temperature and pressure of 400° F and 280 psi respectively.

Figure 8: Section of pipe with thinning wall

Due to the inability to repair this line without taking it out of service, which would entail a unit shut down, it was decided to pursue repairing it while in service utilizing either a repair clamp or a composite wrap system to prevent a leak during continued operation. The defect was in a section of pipe approximately 2 feet in length and thus using a repair clamp that size on a 10" line would prove to be very costly and cumbersome. The primary objective in repairing thinning pipe is to restore the structural strength in order to prevent catastrophic failure. Additionally, the repair must be resistant to corrosion from the product in case the pipe does thin to failure. Another factor being considered while deciding the repair form was the relatively high temperature of the line.

After submitting details on the repair job to NRI engineering, it was determined per ASME calculations that 8 layers of wrap would be required to fully restore the structural integrity of the pipe. The repair was performed in cool weather conditions, helping maintain a skin temperature of around 250° F during installation of the wrap system. The line was prepared by grit blasting to a clean, rough surface according to NACE 2 (SA 2.5) standards.

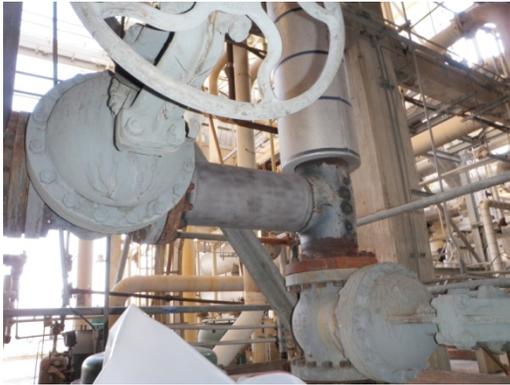
**Figure 9: Surface preparation of the pipe section to be repaired**

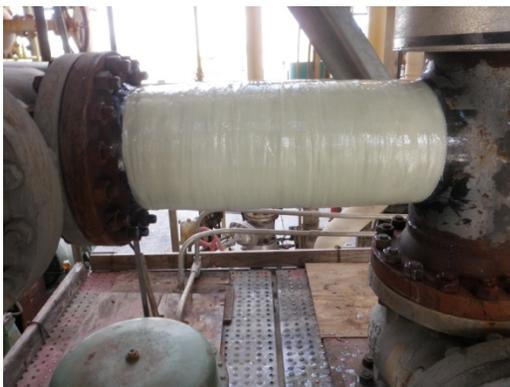
**Figure 10: Installation of the composite repair system**

The custom-woven, E-glass fiber wrap system was thoroughly impregnated with the epoxy formula using methods suggested by the manufacturer. Sufficiently long curing time of the epoxy enabled the tape to be wrapped on the pipe in the manner prescribed without gelling too quickly for effective application. Although some small amount of epoxy run off was present, it was not significant, which helped ensure a thorough wet on wet application of the composite layers. After the installation of the composite system, a layer of compression film was used to hold the epoxy formula during curing.

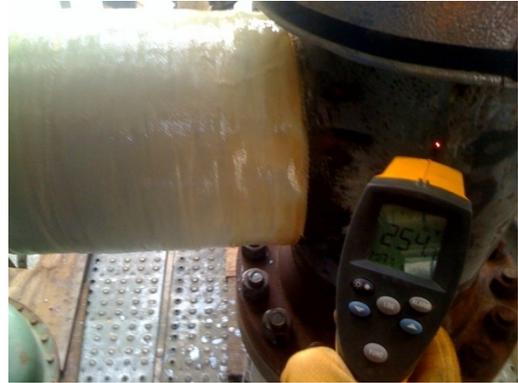
**Figure 11: Measurement of service temp for composite repair**

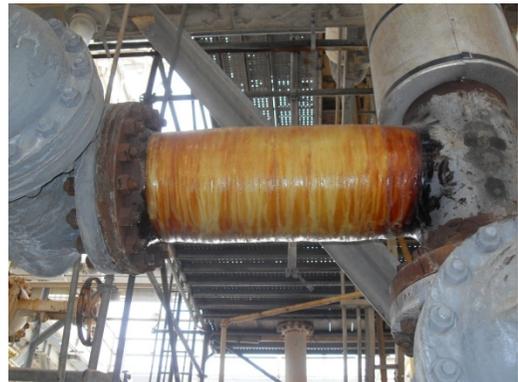
installation to ensure proper resin consistency, curing and hardness. The repair system was visited after a few months to check for any damage. Besides an expected change in color to dark brown, the composite system appeared to retain its integrity.

**Figure 12: Composite repair after 6 months in service with no failure**
