THERMO-WRAP™ CF

10" OD TEE REPAIR & REHABILITATION, MEXICO

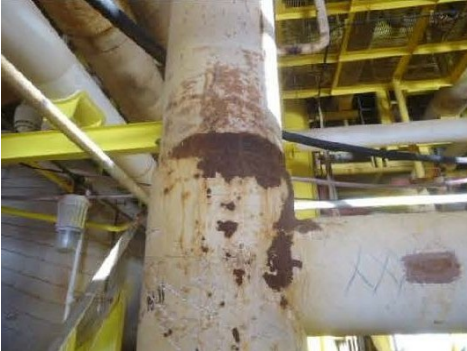
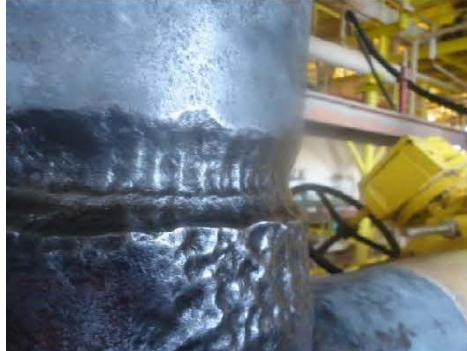
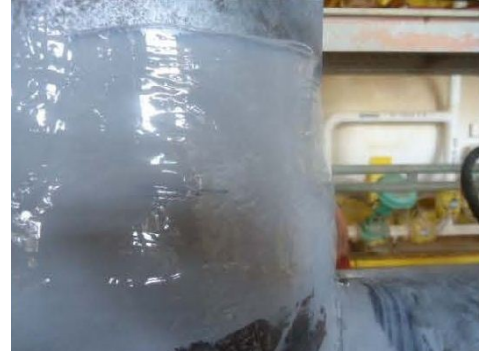
This 10" OD tee petroleum line on an offshore oil platform in Mexico was experiencing severe pitting due to atmospheric conditions causing a 50% wall loss over a 2'6" (.8m) section.

The first step in the repair process was to complete surface preparation in accordance with SSPC-SP3 "Power Tool Cleaning" using an MBX Bristle Blaster. Next, the defects were coated using Syntho-Poxy™HC, a high compression strength liquid epoxy which provides a load transfer medium. Then Thermo-Poxy™ epoxy was applied over the entire repair area to provide corrosion protection to the bare steel, locking out any environmental atmospheric conditions while also acting as a primer for Thermo-Wrap™CF, a chemically resistant carbon fiber composite repair system which was developed for high temperature applications. Thermo-Wrap™CF carbon fiber composite wrap was applied at the calculated number of layers over the required repair length, fully restoring the integrity of the pipe. Lastly, Syntho-Glass®UV was applied to provide UV stabilization for the composite repair system.
