THERMO-WRAP™ CF

30" OD REPAIRS & REHABILITATION, MEXICO

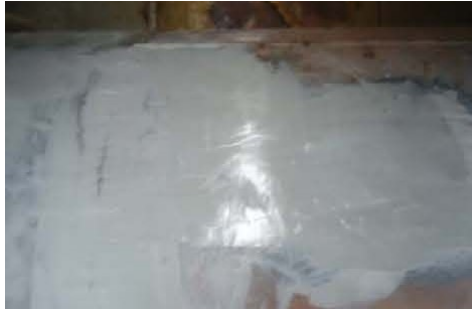
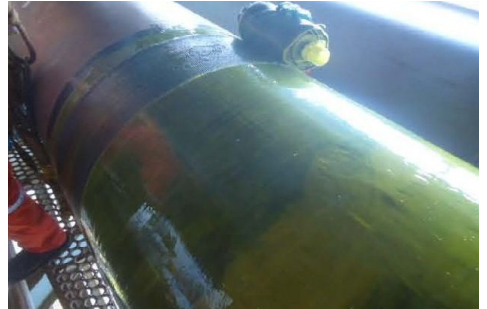
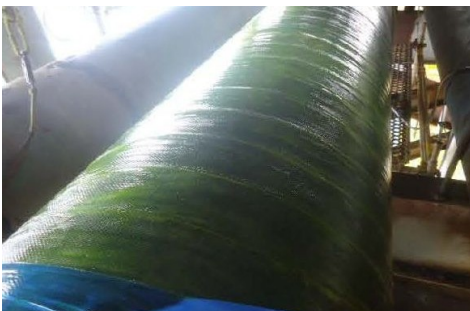
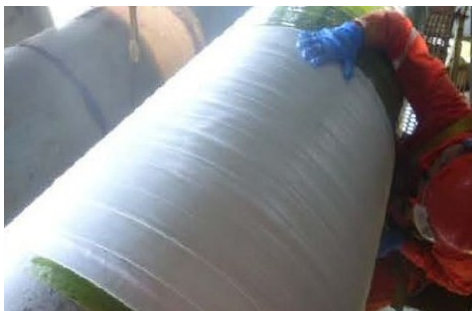
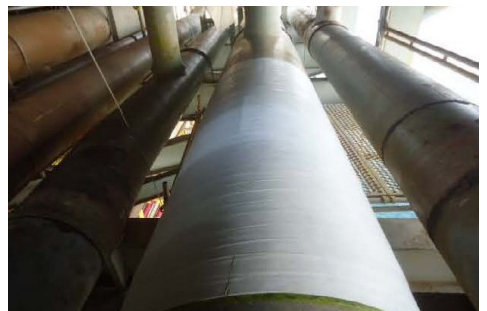
An offshore oil platform in Mexico was experiencing severe pitting on a 30" OD petroleum line due to atmospheric conditions. Over a period of time, these elements caused a 50% wall loss along a 6'5" (2m) section.

This line needed an immediate repair to prevent shutdown, and operated at 43 psi (2.9 bar) and 86°F (30°C).

First, surface preparation was completed on pipeline in accordance with SSPC-SP3 "Power Tool Cleaning" before the defects were filled using Syntho-Poxy™HC, a high compression strength liquid epoxy which acts as a load transfer medium. In order to lock out any future atmospheric conditions, Thermo-Poxy™ epoxy was applied over the entire repair area. This provides corrosion protection to the bare steel, as well as a primer for the composite layer of Thermo-Wrap™CF, a chemically resistant carbon fiber composite repair system which was developed for high temperature applications. The Thermo-WrapCF carbon fiber composite wrap was applied at the calculated number of layers over the required repair length, fully restoring the integrity of the pipe. To provide UV stabilization to the composite repair system, Syntho-Glass®UV was applied as the final layer.

This repair was completed by certified technicians in only a couple of hours, and fully restored the line to its original design specifications.
