THERMO-WRAP™ CF

30" OD REPAIRS & REHABILITATION, MEXICO

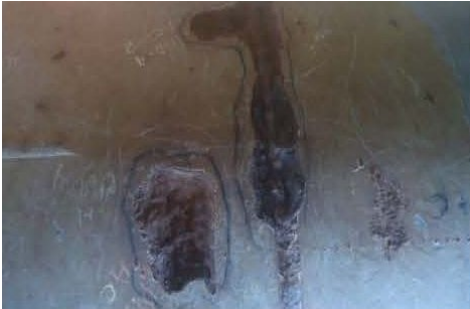
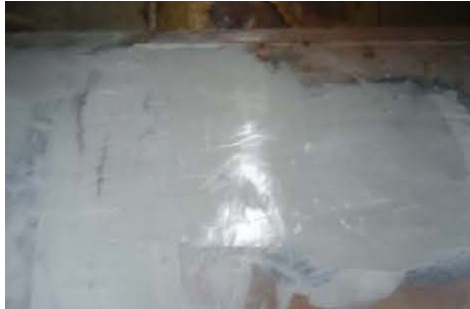
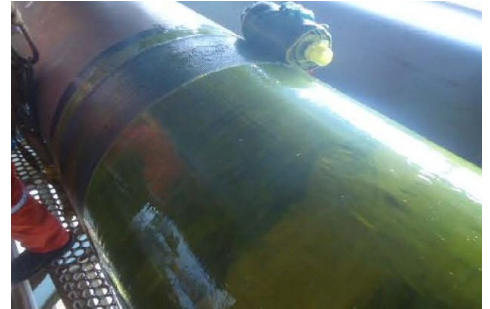
An offshore oil platform in Mexico was experiencing severe pitting on a 30" OD petroleum line due to atmospheric conditions. Over a period of time, these elements caused a 50% wall loss along a 6'5" (2m) section.

First, surface preparation was completed on pipeline in accordance with SSPC-SP3 "Power Tool Cleaning" before the defects were filled using Syntho-Poxy™HC, a high compression strength liquid epoxy which acts as a load transfer medium. In order to lock out any future atmospheric conditions, Thermo-Poxy™ epoxy was applied over the entire repair area. This provides corrosion protection to the bare steel, as well as a primer for the composite layer of Thermo-Wrap™CF, a chemically resistant carbon fiber composite repair system which was developed for high temperature applications. The Thermo-Wrap CF carbon fiber composite wrap was applied at the calculated number of layers over the required repair length, fully restoring the integrity of the pipe. To provide UV stabilization to the composite repair system, Syntho-Glass®UV was applied as the final layer.
