THERMO-WRAP™ CF

36" OD REPAIR & REHABILITATION, MEXICO

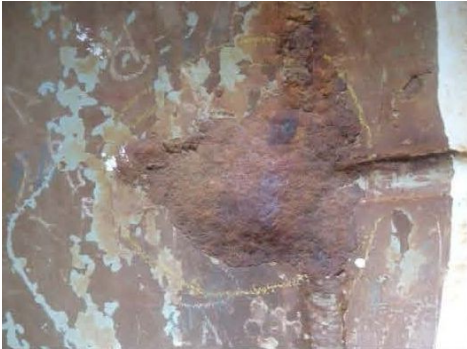
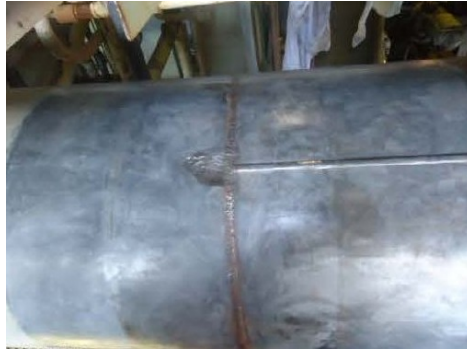
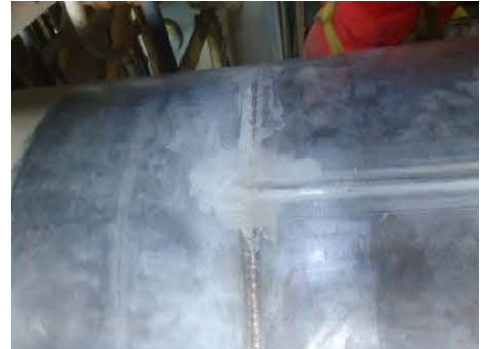
A 36" OD petroleum line located on an offshore oil platform in Mexico was experiencing severe pitting due to atmospheric conditions, causing a 40% wall loss along a 3'2" (1m) section.

The repair area was prepared in accordance with SSPC-SP3 "Power Tool Cleaning" before the defects were filled using Syntho-Poxy™HC, a high compression strength liquid epoxy which provides a load transfer medium. Thermo-Poxy™ epoxy was then applied over the entire repair areas to provide corrosion protection to the bare steel, locking out any atmospheric conditions from the environment while also acting as a primer for Thermo-Wrap™CF, a chemically resistant carbon fiber composite repair system which was developed for high temperature applications. The Thermo-Wrap™CF carbon fiber composite wrap was applied at the calculated number of layers over the required repair length, fully restoring the integrity of the pipe. Finally, Syntho-Glass®UV was applied to provide UV stabilization for the composite repair system.
