THERMO-WRAP™

24" OD CAISSON REPAIR & REINFORCEMENT, UK

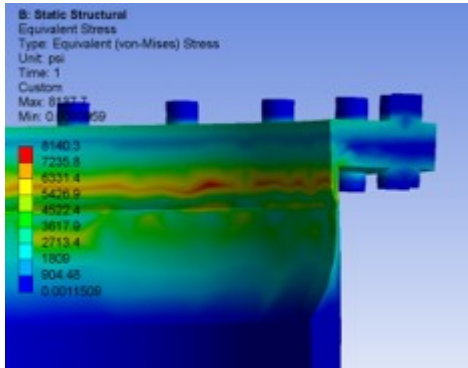
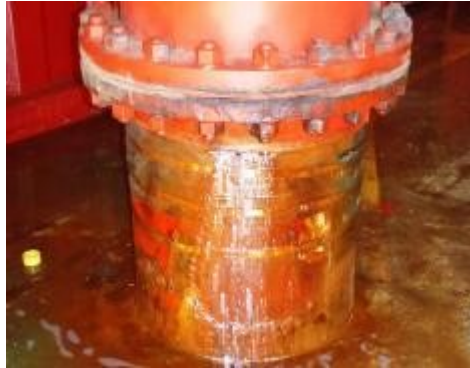
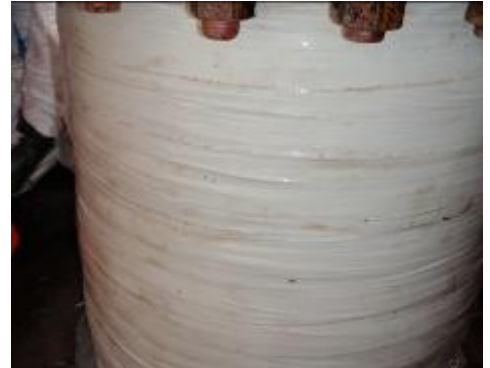
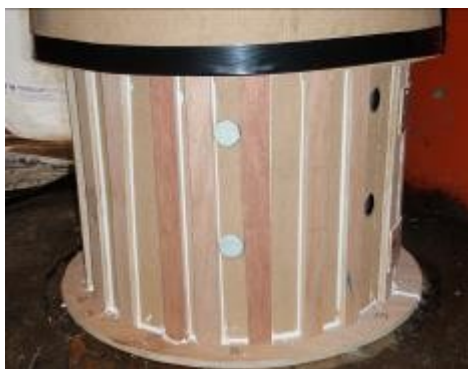
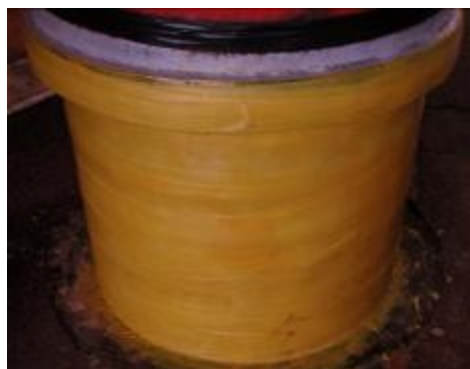
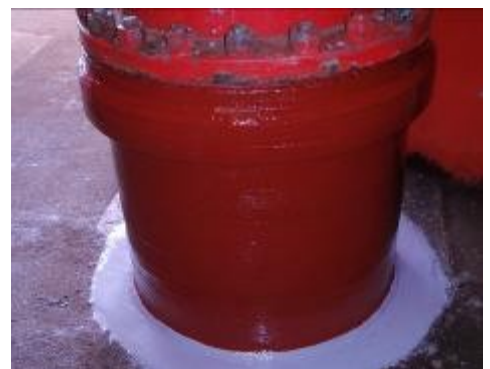
Due to internal corrosion, a large thru-wall defect occurred near a 24" raised face flange. In addition to the internal corrosion, concerns were raised on whether the line could support the axial loads generated by the rise of pipe above the flange.

The thru-wall defect was repaired by applying 10 layers of Syntho-Glass®XT, a 54,000 psi (3,724 bar) tensile strength fiberglass wrap. The axial loads were addressed using 2 fabricated metal shutters which extended between the flange and deck creating a 4" (10.2cm) void which was filled with a high compression strength epoxy mortar to disperse the axial load over a larger surface. After the mortar had cured, the shutters were removed and the section of the pipe was wrapped with 10 layers of Thermo-Wrap™, a 100,000 psi (6,895 bar) tensile strength fiberglass wrap system, providing hoop strength and structural integrity to the thinned pipe, now and into the future.
