THERMO-WRAP™

14" OD WITH 12" OD BRANCH REPAIR, UK

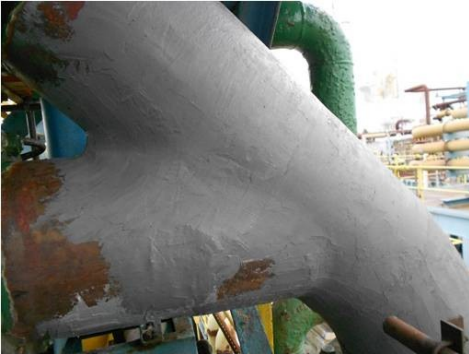
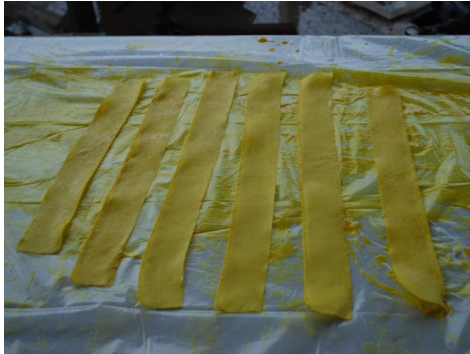
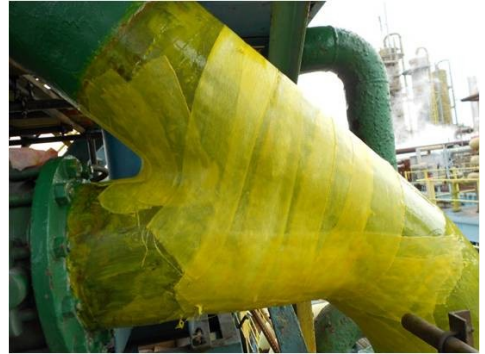
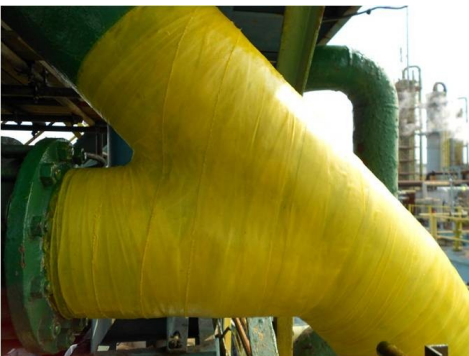
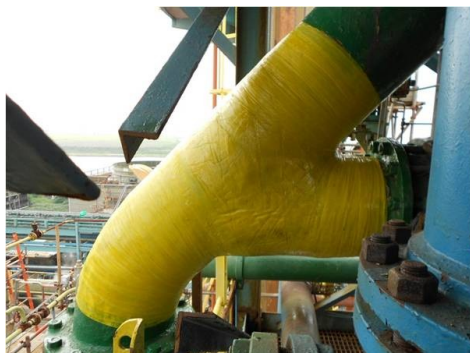
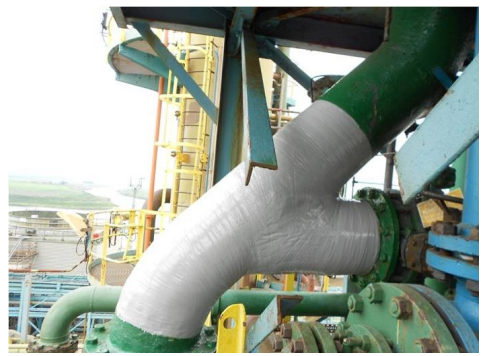
A 2" hole located at the 6 o'clock position on a hydrogen chloride (HCl) absorber line was identified along with several small pinhole leaks within the refinery.

The 14" OD vent pipe was intersected by a 12" OD branch and was carrying nitrogen gas (N₂) and HCl mist. While its operating pressure was 15 psi (1.5 bar), its design pressure was 290 psi (20 bar) as the line acts as a safety relief for the absorber system.

The leaks were sealed using a welded plate, which left the already odd geometry of the "Y" even more difficult to reinforce. Once the surface of the pipes and welded steel plate were prepared using power tools to remove rust, paint, and other foreign matter, the plate, area around the plate and all pits were profiled using Syntho-Poxy™HC, a high compression strength load transferring filler epoxy, to contour the pipe to match its original geometry. Several rolls of Thermo-Wrap were cut into strips prior to priming the pipe with a thin layer of Thermo-Poxy; this assures a wet on wet application. Two layers of Thermo-Wrap were applied using a 50% overlap around the line and in the "Y" section of the branch, assuring complete coverage. The pipe was then wrapped using 10 layers of Thermo-Wrap™, a 100,000 psi (6,895 bar) tensile strength fiberglass wrap system, providing hoop strength and structural integrity, now and into the future.

The repair was carried out by certified technicians in a matter of hours. The line is now fully capable of maintaining the design pressure and safely supporting the vertical rise of pipe.
