THERMO-WRAP™ INSPECTABLE

DOME ROOF REPAIR

USA, MARCH 2014

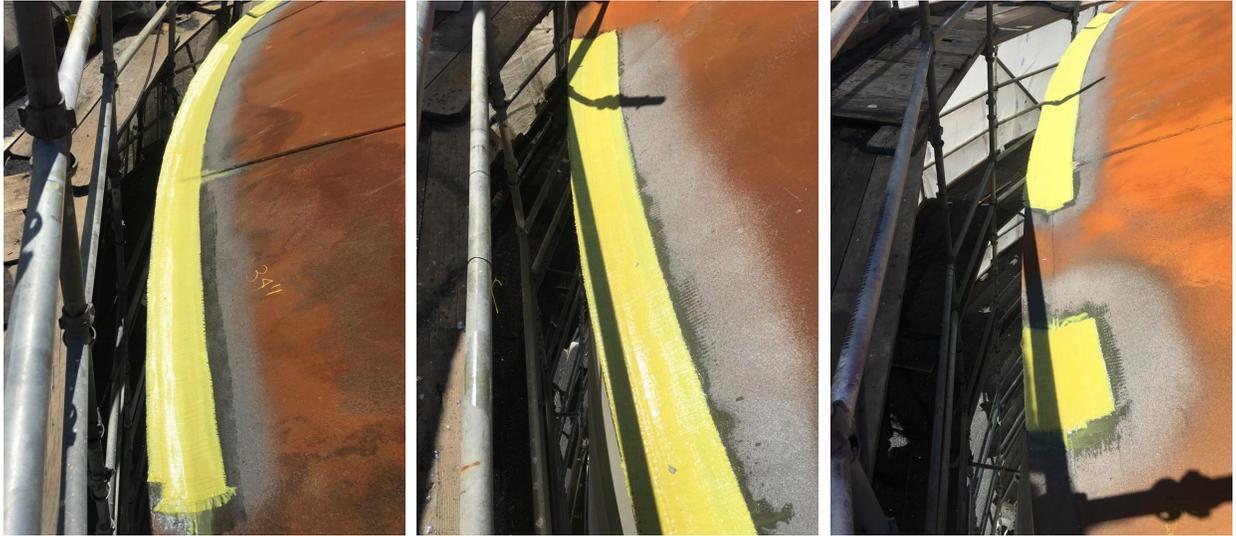
During routine inspection of this tank, a Texas chemical company discovered pinhole leaks which required immediate repair due to environmental concerns of the MEA vapors being released into the atmosphere. The lead time and estimated costs, upwards of \$85-95k, to make the repairs through traditional mechanical methods of cutting, welding and coating, steered this company to NRI for a more cost-effective, timely, long-term 20-year solution.

The tank was approximately 30' in diameter with a dome-shaped roof, operating at 15psi with ambient temperatures and MEA vapor process. Eight repairs were made in total, some leaking, some thin-walled, with all defects found along the perimeter's edge-zones. Due to the high cost and approximately 8-10 days downtime to make a mechanical repair, time which this chemical company did not have, NRI's engineering team designed a repair using composites.

The defect areas of the tank roof were blasted to achieve a 3-4mil anchor profile to promote adhesion of the 3-component composite repair system which consisted of Syntho-Steel™ putty filler, Syntho-Poxy™HC liquid filler, and Thermo-Wrap™Inspectable. In the areas of the roof where pinholes were present, Syntho-Steel was first applied to provide a chemical barrier to the MEA vapors. While Syntho-Steel would not provide long-term chemical protection to MEA, it did provide a stop-gap until the primary system of Syntho-Poxy HC and (4) layers of Thermo-Wrap Inspectable were installed and allowed to fully cure. The areas with severe pitting simply received a coating of Syntho-Poxy HC to create a smooth transition for the installation of the Thermo-Wrap Inspectable composite repair system. In summary, the through-walled areas used a 3-component system consisting of Syntho-Steel to stop-gap the leak until full cure, Syntho-Poxy HC to provide full chemical protection atop the Syntho-Steel, followed by (4) layers of Thermo-Wrap Inspectable to restore the tank's integrity. A topcoat of the plant's specified UV protectant was applied atop the composite system to protect it from future UV degradation.
