# SYNTHO-GLOSS<sup>®</sup> XT

## UTILITY FIELD INSTALLATION: STEEL REINFORCED CONCRETE PIPE

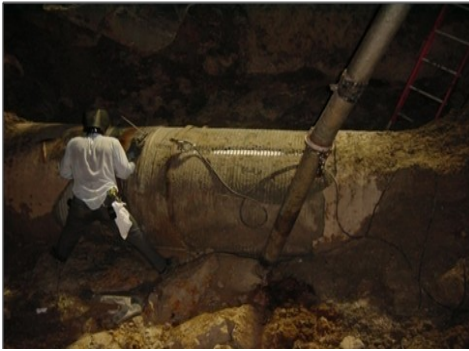
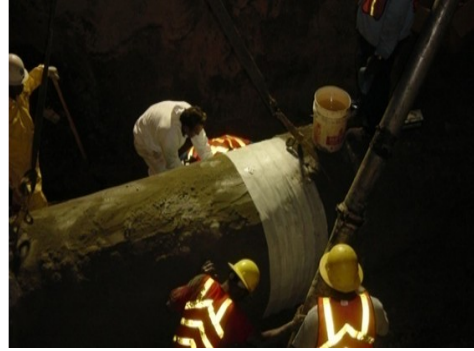
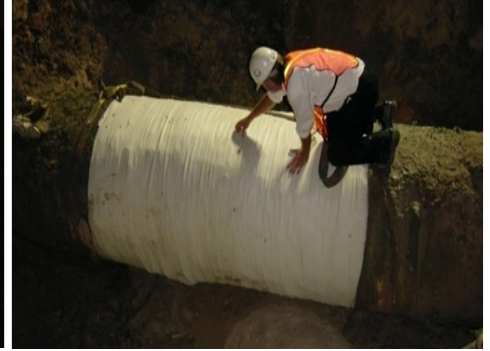
A 20 year old pre-stressed concrete pipe is leaking large amounts of hydrogen sulfide gas, liquefying to sulfuric acid, causing pipe deterioration.

Sewage is percolating through the ruptured municipal force main which is buried 8' (2.4m) underground. Sulfuric acid has eaten through 2' (0.6m) of the pipe's crown.

The crew used an 8" x 50' (20.3cm x 15.2m) roll of Syntho-Glass<sup>®</sup>XT to wrap 8 layers over the 2' (0.6m) repair section, plus an additional 4 to 5' (1.2 to 1.5m) on either side of the patch, as a precautionary measure.

The wrapped area of the pipe is now as strong, or stronger, than the original pipe and allowed the city to save thousands of dollars, as compared to traditional repairs with couplings and forced main shutdown.
