# SYNTHO-GLASS<sup>®</sup> XT

## 14" OD INJECTION LINE, CANADA REINFORCEMENT AND REPAIR

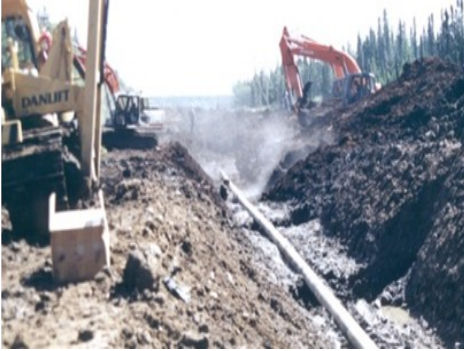
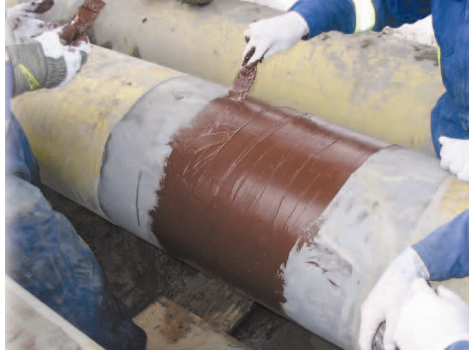
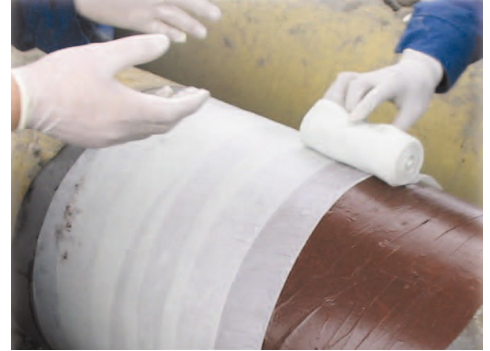
A 14" OD high pressure water injection line has external corrosion on girth welds due to corrosion under shrink sleeves.

Removal of the shrink sleeves revealed external corrosion ranging from 20% to 50% wall loss.

After sufficient surface preparation, Syntho-Steel<sup>™</sup> epoxy mastic was applied to the corroded area and then wrapped with the calculated number of layers of Syntho-Glass<sup>®</sup> XT. This solution brings the HPI line pressure capability back to that of a pristine pipe.

Thirty joints ultimately repaired with each, then subsequently pressure tested with no failure. Normal operations resumed at 2,300 psi (158 bar)
