SYNTHO-GLASS® XT

14" OD INJECTION LINE REINFORCEMENT & REPAIR

CANADA, MARCH 2009

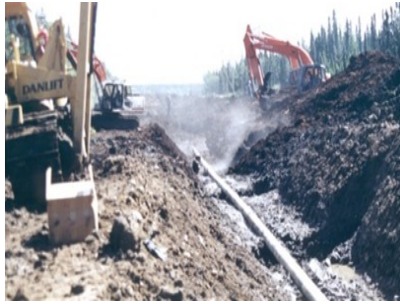
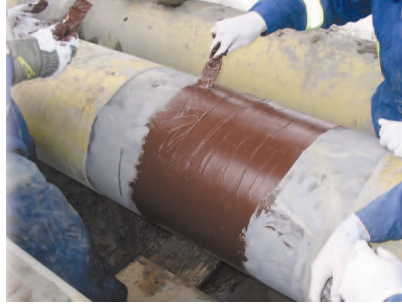
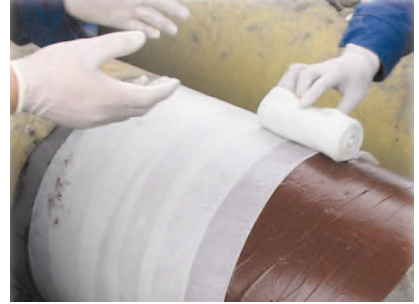
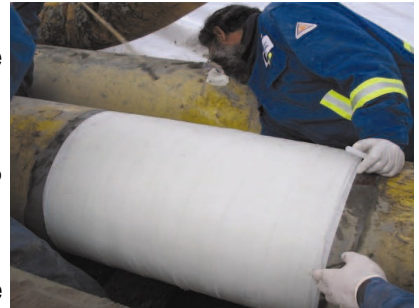
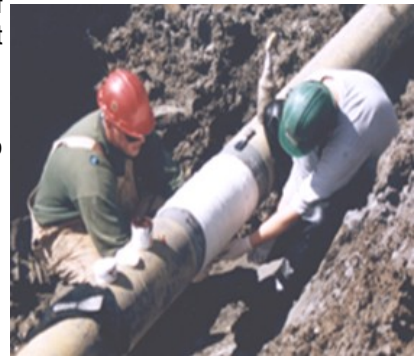
A 14" OD high pressure water injection line has external corrosion on girth welds due to corrosion under shrink sleeves.

Removal of the shrink sleeves revealed external corrosion ranging from 20% to 50% wall loss.

After sufficient surface preparation, Syntho-Steel™ epoxy mastic was applied to the corroded area. The pipe was then protected with the calculated number of layers of Syntho-Glass®XT. This solution brings the HPI line pressure capability back to that of a pristine pipe.

Thirty joints were ultimately repaired, then subsequently pressure tested with no failure. Normal operations resumed at 2,300 psi (158 bar).
