# SYNTHO-GLOSS<sup>®</sup> XT

## GATE VALVE REPAIR REHABILITATION AND REPAIR

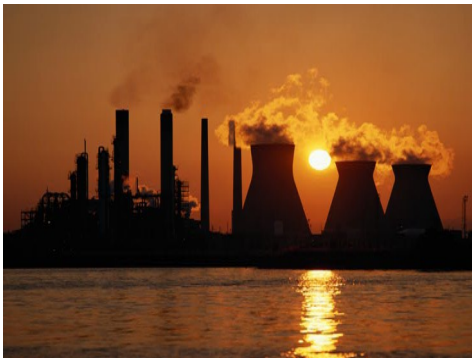
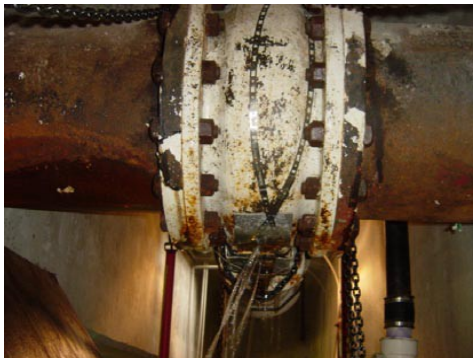
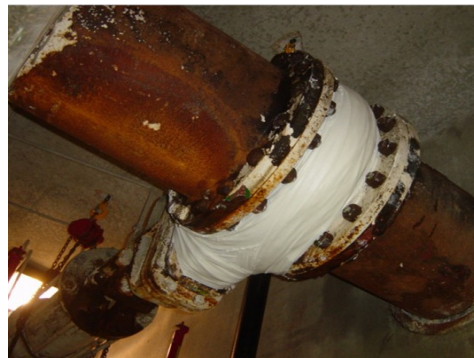
The gate valve coupling is showing major distress areas and leakage and on the verge of a catastrophic breakdown.

The gate valve is suffering from major corrosion and wall loss. Several pinhole size leaks have already begun to form, making the impending repair even more critical.

In order to promote adhesion, the pipe was cleaned by removing rust, paint, and other foreign matter in accordance with Sa2.5, NACE 2 or near white metal. It was then coated with a two-part Syntho-Subsea™ Kevlar® reinforced epoxy. The two-part epoxy halted the corrosion and ensured a water tight seal. The valve was then wrapped with multiple layers of Syntho-Gloss<sup>®</sup> XT which provides structural integrity to the repair system.

The repair was an immediate success, as the gate valve now has even more strength than the original pipe and valve at the time of installation. The valve once again meets the MAOP and is also protected from further corrosion.
