COMPOSITE GUARD™ FP

PROCESS PIPING REHABILITATION

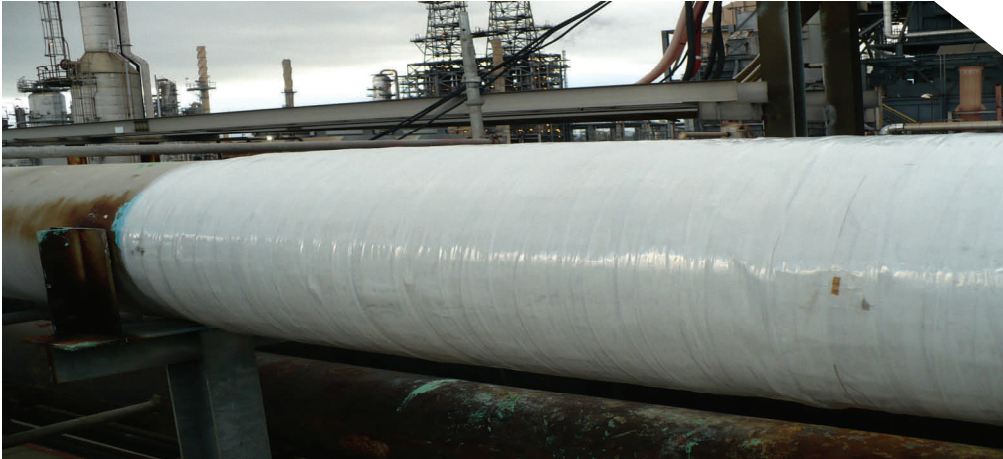
A section of 24" pipe, at a US refinery was experiencing accelerated wall thinning due to external corrosion of the pipe. The contents within the pipe were highly flammable, therefore the repair method required a minimum of a 2 hour fire rating to even be considered. In addition, the pipe could not be shut down for the installation of the repair as the function of the pipe was critical to the refinery's operation.

With the presence of external wall loss, a repair was required in order to sufficiently reinforce the thinned area to prevent failure and keep the system in working order. The flammable contents of the pipe required extra safety precautions to be used in preparation for the repair. The repair was designed for the full 285 psi (20 bar) pressure rating at a constant operating temperature of 155°F (68°C) with expected temperature spikes up to 194°F (90°C).

The Syntho-Glass®XT composite repair system was installed to restore the pipe back to design conditions providing full rehabilitation and structural integrity of the corroded pipe. Due to the flammable contents of the piping system, a fire proofing system, Composite Guard™FP, was installed over the composite repair creating a fire proofing barrier from the exposure of external flames of 1596°F (869°C). The extremely low thermal conductivity of the Composite Guard™FP's nano-technology prevents the composite repair system from reaching temperatures exceeding the HDT or Tg of the composite repair system, thus preventing failure of the composite which could fuel the fire source.

In only a couple of hours, NRI was able to restore the thinned pipe back to design specification while providing an integrated fire proofing system over the composite repair system on a high risk pipe. The result, the pipe could remain in full working operation without the need to shutdown the refinery.
