SYNTHO-SHIELD™

TITANIUM STRESS JOINT RUBBER COATING REPAIR

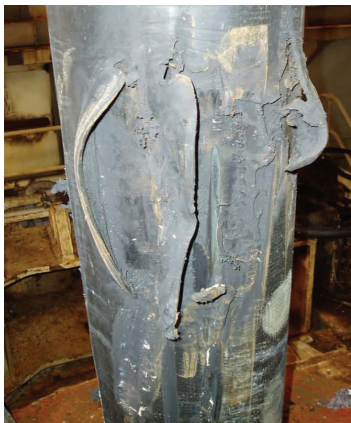
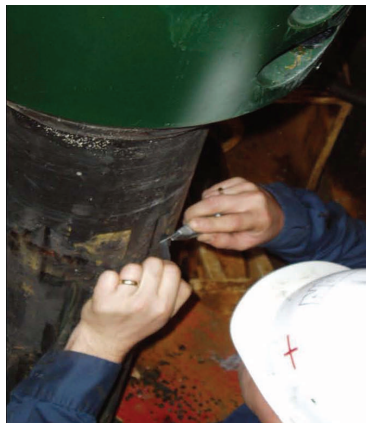
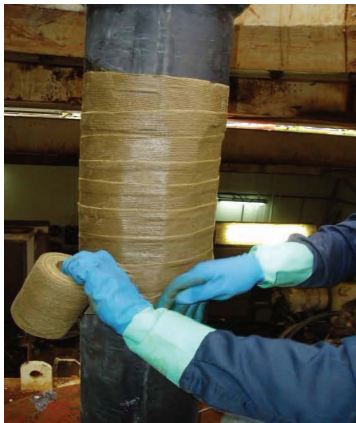
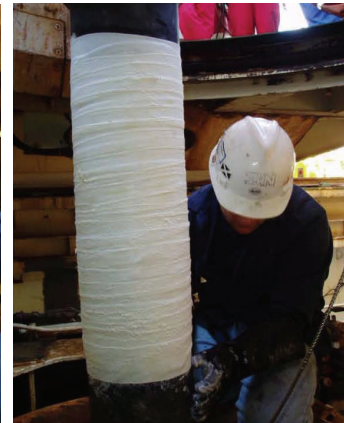
The Titanium Stress Joint, TSJ, rubber coating is damaged from unexpected loop current event during J-Lay.

TSJ was inspected to verify that there was no damage to titanium. In this case, all damage was localized in rubber coating.

Petrolatum Tape undercoating applied for water-proofing and corrosion protection. Syntho-Glass protective outer wrap was applied over a Petrolatum Tape providing mechanical and impact strength.

The TSJ rubber coating repair was completed in a matter of 30 minutes and J-Lay continued. RTIES customers have successfully performed offshore TSJ rubber coating repairs using the Syntho-Shield system, both on-deck and underwater.
