SYNTHO-GLOSS®

PRE-STRESSED CONCRETE PIPE: RAW SEWAGE

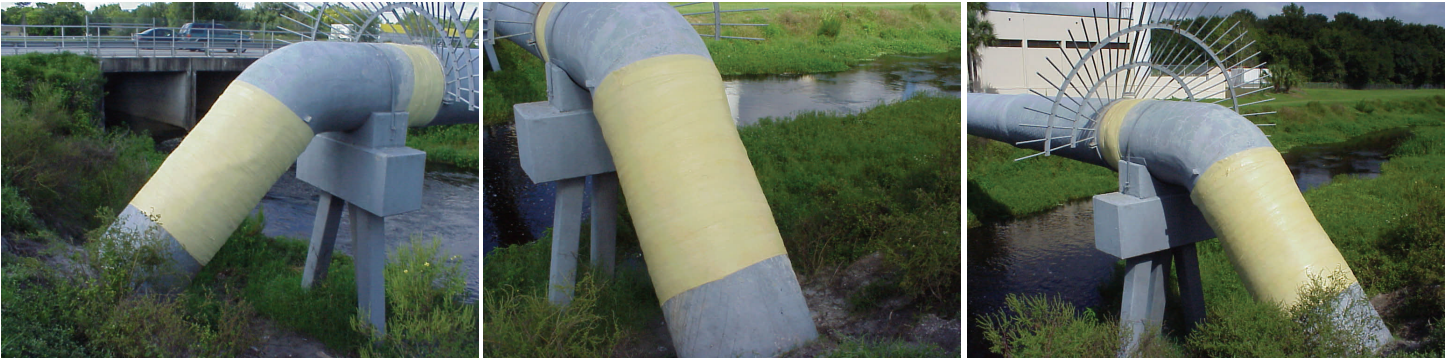
The City of Orlando, FL, had experienced problems with a 42 inch force main that runs from a lift station to the Iron Bridge Water Reclamation Treatment Facility.

One of Orlando's largest, pumps 12 to 20 million gallons of sewage a day to the Iron Bridge Water Reclamation Treatment Facility. Sewage is discharged through five miles of 42-inch diameter PCCP. PCCP is pre-stressed reinforcing wire (rebar) covered with a steel plate, then surrounded by an inner and outer concrete layer. Together, they total two inches thick.

The 20-year-old pre-stressed concrete cylinder pipe (PCCP) had developed a leak adjacent to an aerial crossing. Copious amounts of hydrogen sulfide gas liquefying to sulfuric acid were causing its deterioration. Orlando's Public Works Department (PWD) monitored the pipe regularly, yet it was a resident who, reported sewage percolating out of the ground.

Normally, PWD crews would cut out the corroded section and replace it with repair couplings. This takes 10 to 12 hours. "Had we chosen that option," Proulx said, "major bypass pumping would have been required, since we can't shut down the force main. It would have been a miserable, tough job, and cost the city quite a bit more money." A three-man crew began excavating at midnight when the flow was lowest. The crew discovered sulfuric acid had eaten through two feet of the pipe's crown. After excavating completely around the pipe's full diameter, the men knocked away the outer layers of the pipe and exposed the damaged crown. They cleaned the outside of the pipe and welded a new steel plate to the existing steel cylinder. Then they covered that with an epoxy followed by a quick-setting cement, followed by 8 layers of Syntho-Glass.

"What we needed was a secondary patch to lock the first one in place," Proulx said. "We chose Syntho-Glass® because of its quick cure time, 30 minutes at 75°F, and ease of application."

Using Syntho-Glass, PWD crews successfully repaired the leaking pipe, preventing an ecological and public health catastrophe.
