SYNTHO-GLASS®

PIPELINE INSTALLATION: GATE VALVE

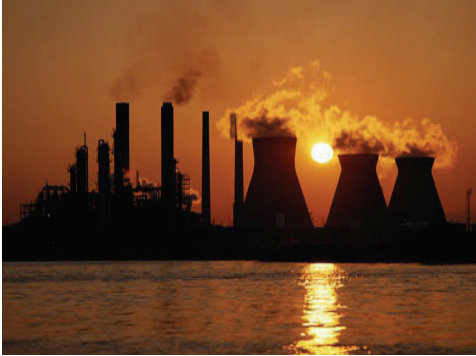
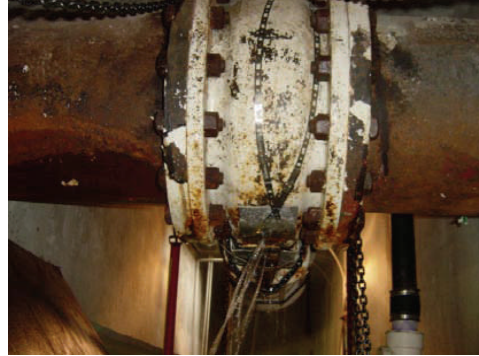
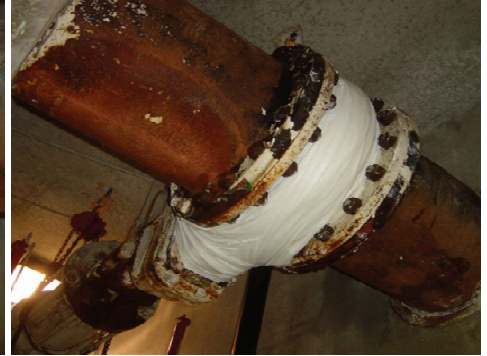
The gate valve coupling is showing major distress areas and is on the verge of a catastrophic breakdown.

The gate valve has major corrosion and wall loss. Several pinhole size leaks have already begun to form, making the impending repair even more critical.

In order to promote adhesion, the pipe was cleaned by removing rust, paint, and other foreign matter in accordance with Sa2.5, NACE 2 or near white metal. It was then coated with a two part Syntho-Subsea™ Kevlar® reinforced epoxy. The two part epoxy halted the corrosion and ensured a water tight seal. The valve was then wrapped with multiple layers of Syntho-Glass® which provides structural integrity to the repair system.

The repair was an immediate success, as the gate valve now has even more strength than the original pipe and valve at the time of installation. The valve once again meets the MAOP and is also protected from further corrosion.
