# TRIDENT-SEAL®

## NATURAL GAS - PDI METER SET

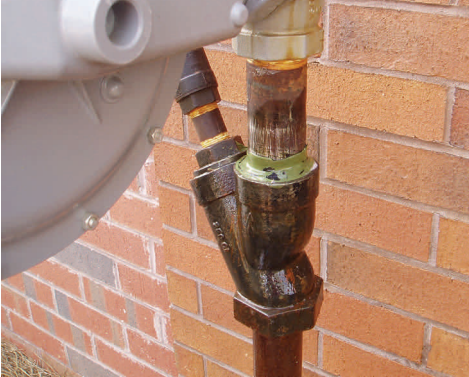
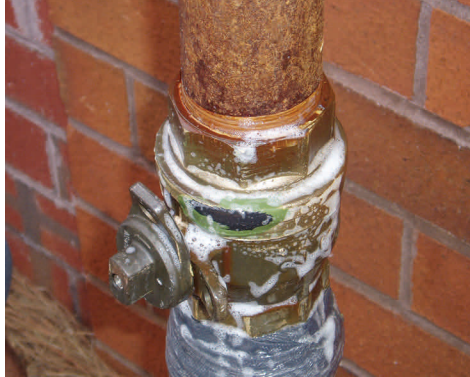
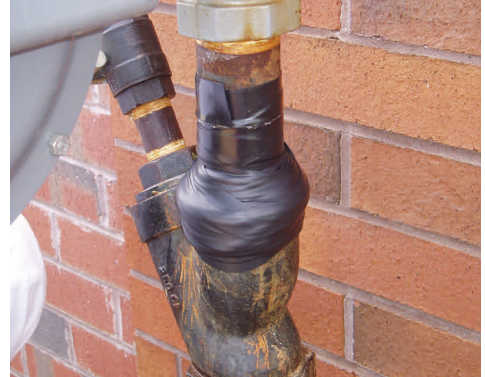
A natural gas distribution meter set supplying natural gas to a strip mall was identified to have several small threaded fuzzi leaks.

The gas utility removed a 4" OD Trident-Seal® kit from the service truck. The leak origination point was verified and the repair area was cleaned utilizing the prepackage emery cloth and solvent wipe located within the kit. The operator qualified utility worker applied a circular rope of the kneaded Trident-Seal Putty around the leaking threaded joint. The Trident-Seal Pressure Sealing Tape was applied directly over the Trident-Seal epoxy putty, forcing the putty into the threads and sealing the leak. The simplistic combination of these two materials allowed the gas utility to verify that the leak was sealed in less than 10 minutes from the start of the repair. After leak soap was applied, to verify the leak was stopped, the gas utility remove the soap and applied the water activated Trident-Glass™ Outer Wrap to permanently hold the repair system in place and add reinforcement to the pipe work.

The Trident-Seal composite repair system eliminated the need to replace or break down the pipe work. The repair, which could have taken a substantial amount of time and hundreds of dollars in man hours and lost revenue for mall operators, was completed inexpensively in a matter of 30 minutes.
