TRIDENT-SEAL®

NATURAL GAS - VALVE REPAIR

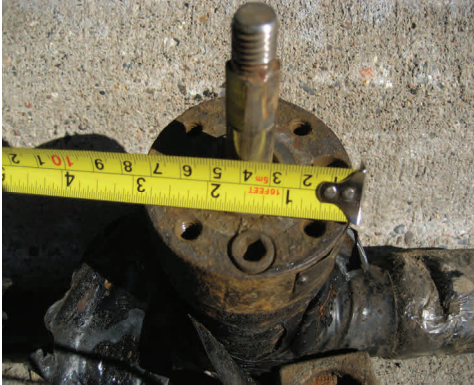
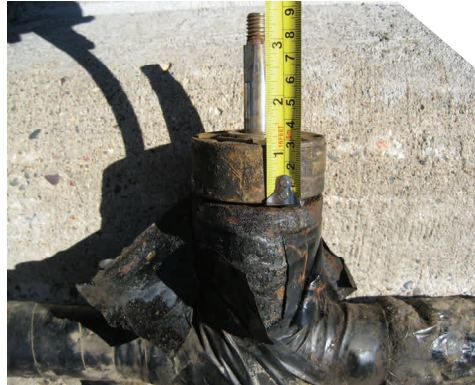
An in service natural gas distribution valve located in a remote country side setting was damaged during a service repair. The result of the damage was a small fuzzi leak that was migrating around the flange and one of the bolts.

The origin of the leak was verified and a TS2580 Trident-Seal® repair kit was pulled from the service truck. The valve was cleaned by removing rust, paint, and other foreign matter to promote adhesion, with the pre-packed emery cloth and solvent cleaning wipe, components provided within the TS2580 Trident-Seal kit. The operator qualified applicator applied the kneaded Trident-Seal Putty adjacent to the leak point then mechanically forced the putty into the leak point with the Trident-Seal Pressure Sealing Tape. The simplistic combination of these two materials allowed the gas utility to verify that the leak was sealed in less than 10 minutes from the start of the repair. After leak soap was applied, verifying that the leak has been stopped, the gas utility applied the water activated Trident-Glass™ Outer Wrap to permanently hold the repair system in place and add reinforcement to valve.

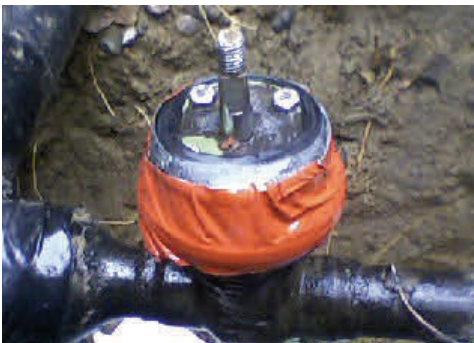
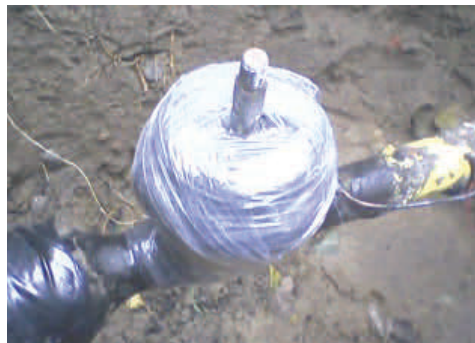
The Trident-Seal composite repair system eliminated the need to replace the valve. The repair, which could have taken a substantial amount of time and hundreds of dollars, was completed inexpensively in a matter of 30 minutes.
