TRIDENT-SEAL™

NATURAL GAS - VALVE REPAIR

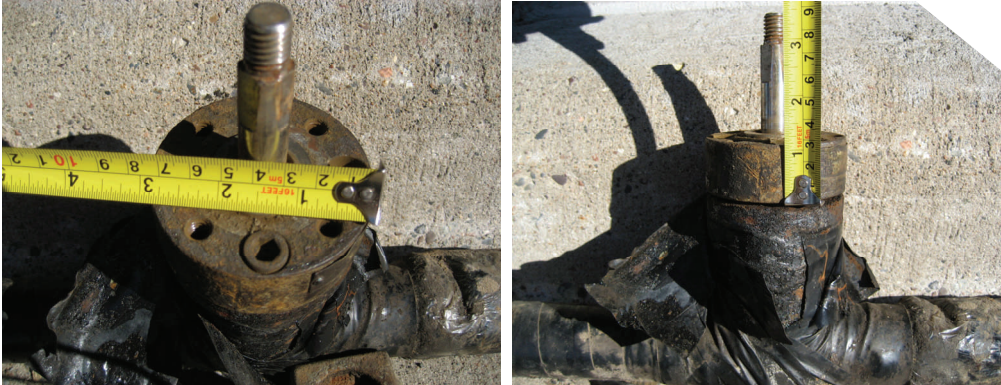
An in service natural gas distribution valve located in a remote country side setting was damaged during a service repair. The result of the damage was a small fuzz leak that was migrating around the flange and one of the bolts.

The origin of the leak was verified and a TS2580 Trident-Seal™ repair kit was pulled from the service truck. The valve was cleaned by removing rust, paint, and other foreign matter to promote adhesion, with the pre-packed emery cloth and solvent cleaning wipe, components provided within the TS2580 Trident-Seal kit. The operator qualified applicator applied the kneaded Trident-Seal Putty adjacent to the leak point then mechanically forced the putty into the leak point with the Trident-Seal Pressure Sealing Tape. The simplistic combination of these two materials allowed the gas utility to verify that the leak was sealed in less than 10 minutes from the start of the repair. After leak soap was applied, verifying that the leak has been stopped, the gas utility applied the water activated Trident-Glass™ Outer Wrap to permanently hold the repair system in place and add reinforcement to valve.

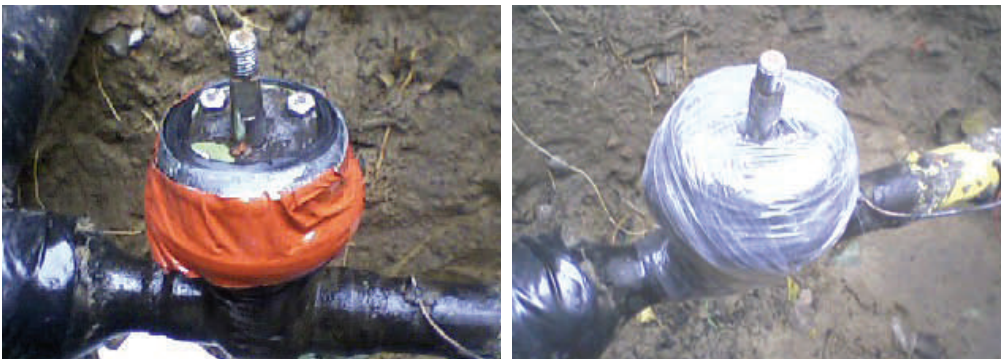
The Trident-Seal composite repair system eliminated the need to replace the valve. The repair, which could have taken a substantial amount of time and hundreds of dollars, was completed inexpensively in a matter of 30 minutes.
