SYNTHO-GLASS®UP

REFINERY 3" PRESSURIZED LEAK REPAIR

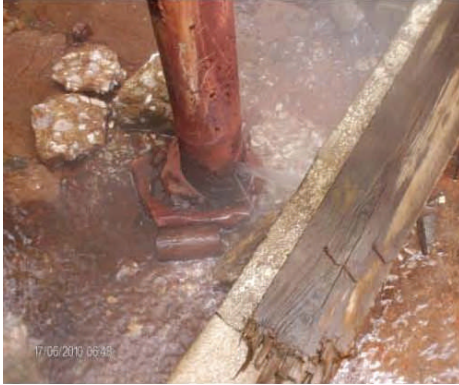
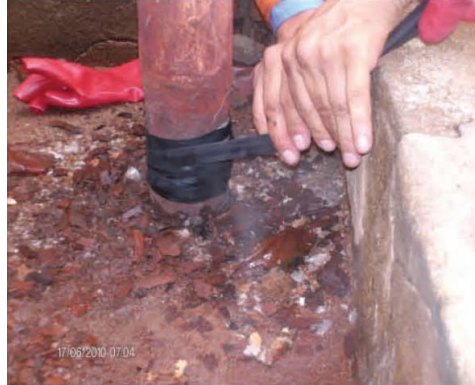
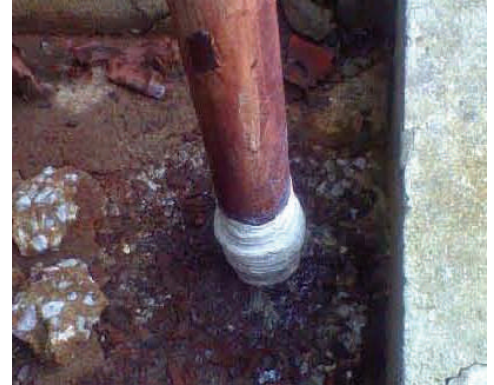
A refinery in Tula, Hidalgo Mexico located a pinhole leak on a 3.5" OD steel pipe.

The pipe is pressurized at 30 psi (2 bar), carrying water and oily condensate at 122°F (50°C), and cannot be shut down for repair.

The refinery simply used one Syntho-Glass®UP415 Kit to repair the leak. After preparing the surface using the included sanding cloth and solvent cleaning wipe, Syntho-Steel™ load transfer putty was applied to seal the leak and was held in place using Pressure Sealing Rubber Tape. Eight layers of Syntho-Glass® was then applied to strengthen the pipe and rebuild the pipe wall back to MAOP.

The repair was completed in less than 30 minutes without the need to shutdown, saving precious time and money.
