VIPER-SKIN™

12"OD DENT REPAIR

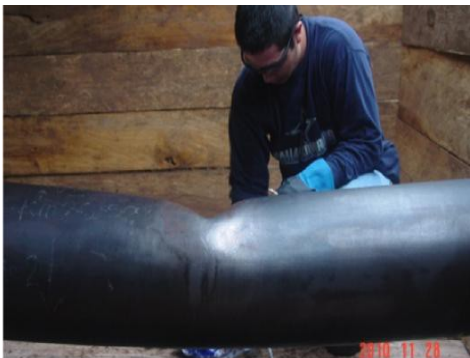
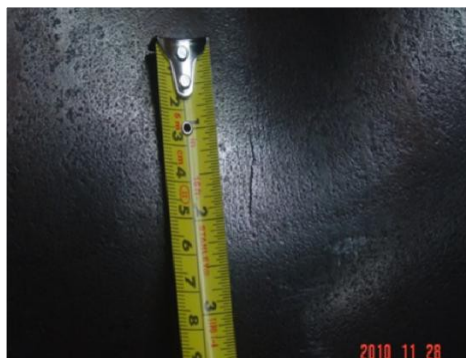
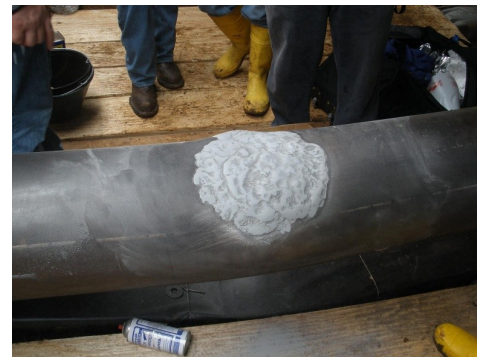
A 12" OD carbon steel pipe operating at 900 psi (62 bar) located in the rainforest of Ecuador was impacted by a falling tree. The oil & gas company required an immediate solution that could be effectively and easily installed in the rainforest to prevent an unexpected shutdown or catastrophic rupture in the pipeline.

The 900 psi (62 bar) 12" natural gas pipeline was forced to reduce pressure by 40% due to a 60 mm dent caused by a falling tree. The relative humidity at the work site was 98% requiring the working conditions to be confined within a wood framed tent.

In order to promote adhesion, the pipe was cleaned by removing rust, paint, and other foreign matter in accordance with Sa2.5 or NACE 2. A 12,000 psi (827 bar) high compression strength filler called Syntho-Steel™ was used to reconfigure the dented pipe back to its original circumference. 30 mils of Syntho-SubSea™LV epoxy was applied over the entire repair area to provide corrosion protective over the bare steel pipe effectively locking out any atmospheric conditions from the surrounding rainforest. The Syntho-Steel & Syntho-SubSeaLV work together to transfer the hoop loading of the 900 psi (62 bar) carbon steel pipe into the high tensile strength of the Viper Skin™ carbon fiber composite wrap, fully restoring the integrity of the pipeline.

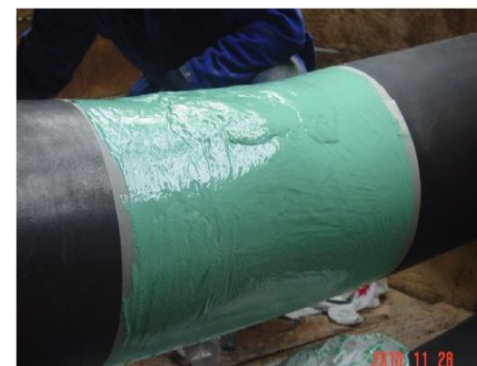
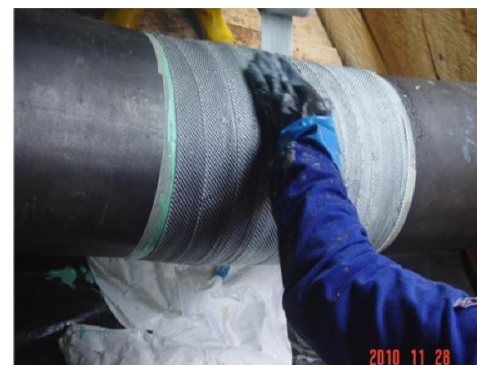
The Viper Skin composite repair system eliminated the need to immediately replace the defective section of pipe. The entire repair was completed inexpensively in a matter of hours. Viper Skin fully restored the pipe's hoop and axial strength to enable full pipeline operations.
