VIPER-SKIN™

12"OD Dent Repair

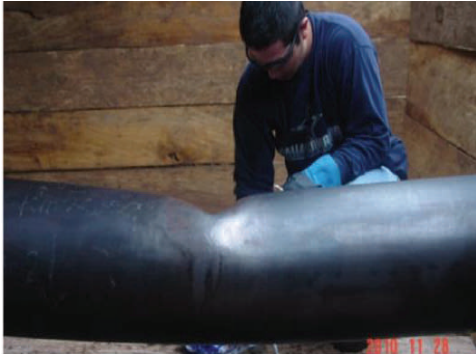
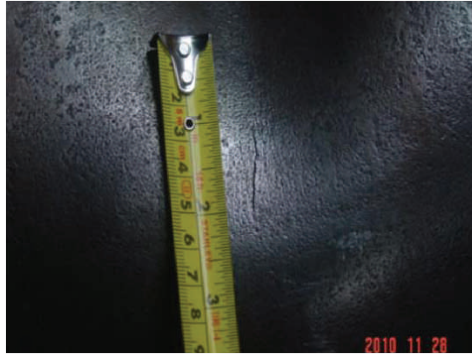
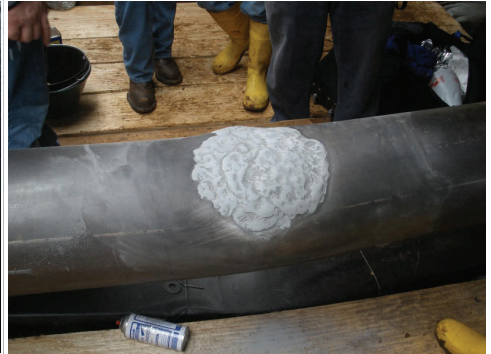
A 12" OD carbon steel pipe operating at 900 psi (62 bar) located in the rainforest of Ecuador was impacted by a falling tree. The oil & gas company required an immediate solution that could be effectively and easily installed in the rainforest to prevent an unexpected shutdown or catastrophic rupture in the pipeline.

The 900 psi (62 bar) 12" natural gas pipeline was forced to reduce pressure by 40% due to a 60 mm dent caused by a falling tree. The relative humidity at the work site was 98% requiring the working conditions to be confined within a wood framed tent.

In order to promote adhesion, the pipe was cleaned by removing rust, paint, and other foreign matter in accordance with Sa2.5 or NACE 2. A 12,000 psi (827 bar) high compression strength filler called Syntho-Steel™ was used to reconfigure the dented pipe back to its original circumference. 30 mils of Syntho-SubSea™LV epoxy was applied over the entire repair area to provide corrosion protective over the bare steel pipe effectively locking out any atmospheric conditions from the surrounding rainforest. The Syntho-Steel & Syntho-SubSeaLV work together to transfer the hoop loading of the 900 psi (62 bar) carbon steel pipe into the high tensile strength of the Viper Skin™ carbon fiber composite wrap, fully restoring the integrity of the pipeline.

The Viper Skin composite repair system eliminated the need to immediately replace the defective section of pipe. The entire repair was completed inexpensively in a matter of hours. Viper Skin fully restored the pipe's hoop and axial strength to enable full pipeline operations.
