SYNTHO-GLASS[®] XT

PIPELINE REINFORCEMENT AND REPAIR

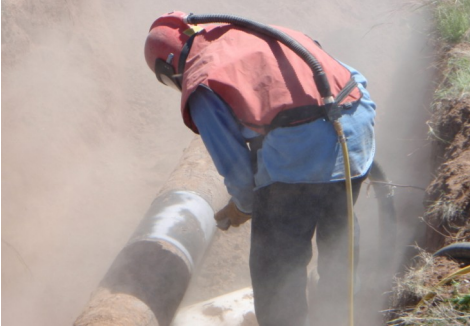
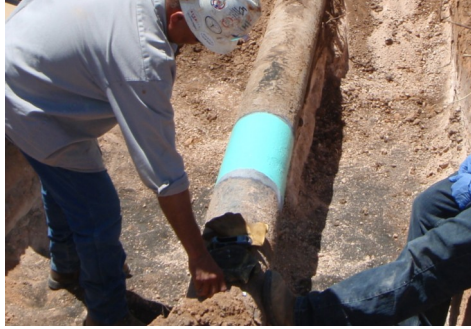
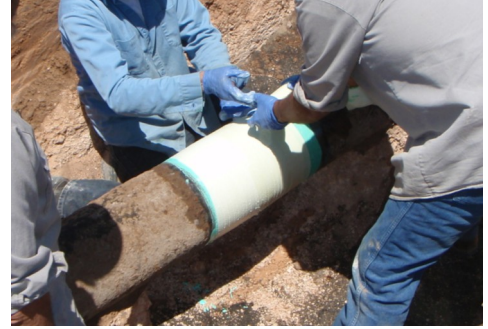
This 900 psi, 10.75" OD pipe was showing signs of substantial wall loss over an 8-1/4" area.

In order to promote adhesion, the pipe was sand blasted to remove rust, paint, and other foreign matter, then cleaned using a solvent wipe. Pits were filled using Syntho-Steel™ load transfer putty then the entire repair area was coated with Syntho-SubSea™LV, a high compression strength two part Kevlar® reinforced epoxy. The two part epoxy stopped the corrosion and provided a load transfer median engineered to cycle and work with the 900 psi (62 bar) line. The line was then wrapped with 8 layers of Syntho-Glass®XT, a 54,000 psi (3723 bar) tensile strength fiberglass composite sleeve, which provides structural integrity to the composite repair system.

The repair was completed inexpensively in less than one hour. A repair that could have otherwise could have taken weeks. Syntho-Glass XT composite system fully restored the pipe's hoop and axial strength to enable operations at full MAOP of 900 psi (62 bar).
