SYNTHO-GLASS[®] XT

OFFSHORE PIPELINE REHABILITATION

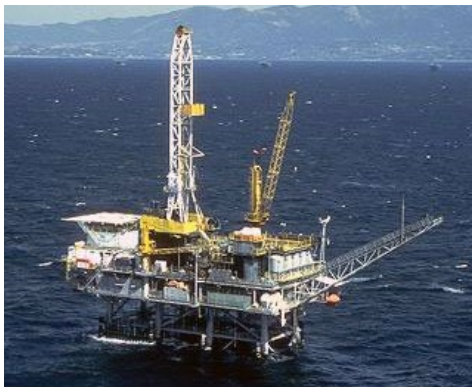
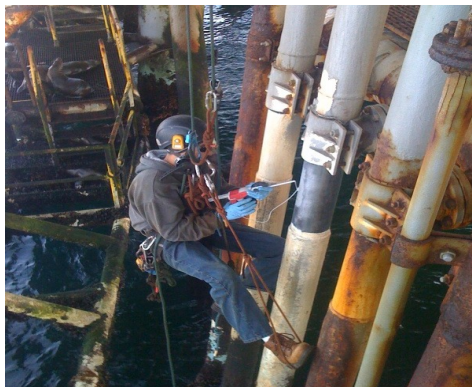
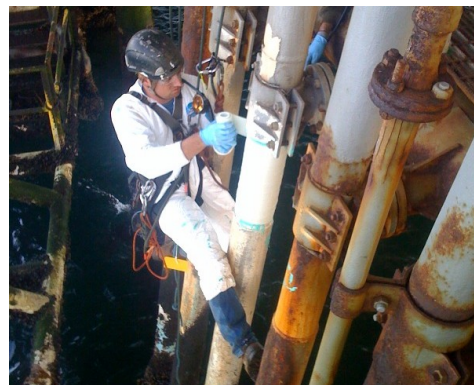
An offshore platform located in Southern California was performing routine inspection when they identified a dent in a high pressure oil riser. The cause of the mechanical damage was the result of a supply boat impacting the riser during rough seas. The severity of the damage would result in a shutdown of the pipeline, effectively stopping the production of oil and resulting in a enormous production revenue losses.

With a substantial dent in the 6" OD riser and concerns of additional loads from wave and tidal action fears of a disaster were imminent. The damaged pipeline was also the oil rig's main space production feed line which would result in a very expensive unexpected shutdown if the riser was to be replaced. The unexpected shutdown would cost the offshore rig roughly \$5,000 an hour, or more than \$120,000 a day. Replacing the riser would require timely raw material logistics and origination of heavy equipment to perform the repair resulting in a very costly shutdown. NRI was immediately contacted to engineer an online solution to prevent disruption in production.

The pipe was cleaned by removing rust, paint, and other foreign matter using power tools and rope access. The dent was filled with a 17,000 psi high compression strength liquid epoxy called Syntho-Poxy[™]HC by rope access. The applicator friendly liquid epoxy was dispensed from a self mixing 50ml cartridge with a quick cure profile to reconfigure the dent to match the original geometry of the pipe. With the pipe back to it's original geometry the entire repair length was recoated with 30mils of an anticorrosion, adhesion promoting epoxy called Syntho-SubSea[™]LV. The two part epoxy effectively stops any future corrosion within the offshore environment while also providing a load transfer median engineered to cycle and work with the 2130 psi (147 bar) design pressure of the riser. Within a matter of an hour the dent was filled and the line was recoated before wrapping the entire repair length with Syntho-Glass[®] XT, a 54,000 psi (3723 bar) tensile strength fiberglass composite sleeve, which restores the structural integrity of the riser.

In less than 2 hours, NRI was able to repair an offshore riser that otherwise could have taken a day to repair using traditional replacement methods. NRI completed the project without any loss in production. The gas field is now operating at full capacity.
