SYNTHO-GLASS®XT

PIPELINE INSTALLATION: REINFORCEMENT AND REPAIR

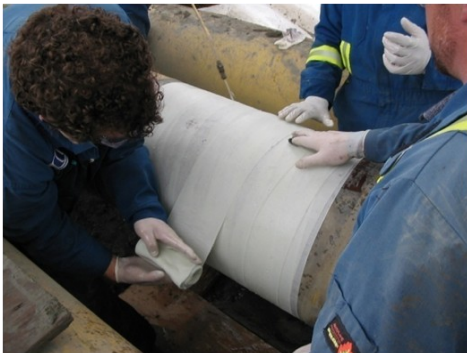
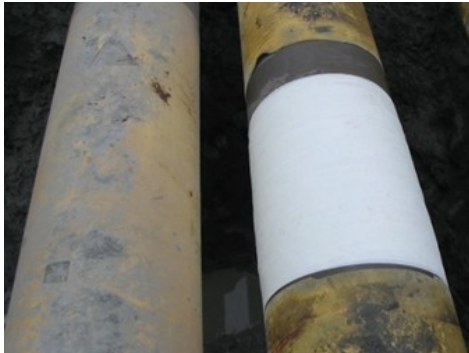
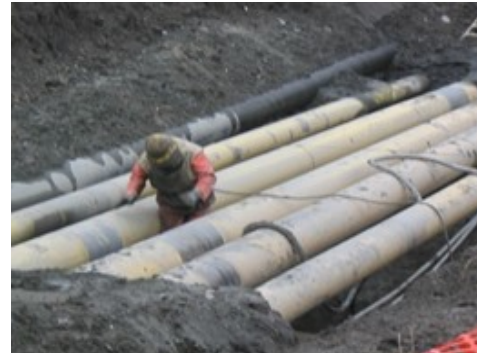
Numerous underground pipelines, with external wall loss and corrosion, are in need of immediate repair. Shutdown of the lines was not an option during repair and retrofit of the pipeline. A refineries loading pipe lines were found to have multiple sections of external wall loss in excess of 50% in some areas of localized pitting.

The pipelines are unearthed to show multiple areas of corrosion damage and external wall loss. The pipes are old, still in workable condition, but in need of immediate repair and reinforcement.

The pipeline problem areas are first prepared by sandblasting, then applying an epoxy filler to fill in the pits with a secondary coat of a mastic epoxy to give added reinforcement and prevent future corrosion. These areas were then wrapped with multiple layers of Syntho-Glass®XT to provide reinforcement, rebuilds the pipe wall, and permanently repair the pipe.

The reinforced pipelines are brought back to their original strength with a permanent repair of their problem areas. The repair was completed without the need to shut down pressure through the lines, thus saving the customer hundreds of thousands in shutdown costs.
