THERMO-WRAP™

CONDENSATE LINE REHABILITATION

CZECH REPUBLIC, JULY 2014

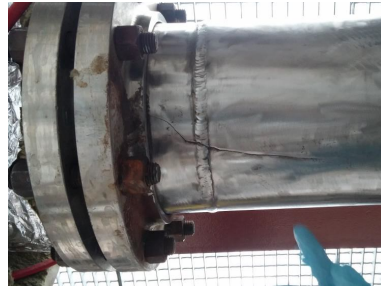
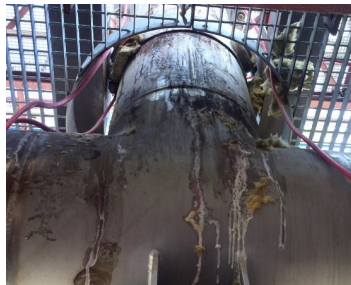
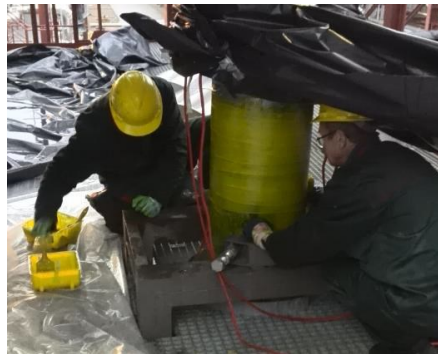
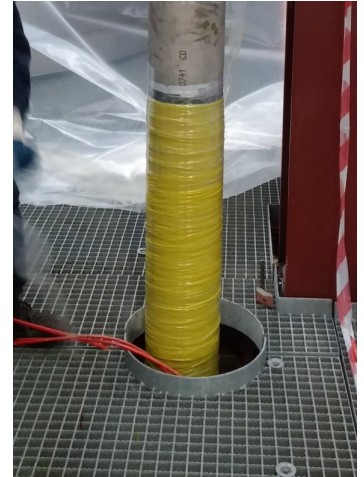
The steel condensate pipes in a butadiene rubber production plant kept experiencing severe corrosion. When replacement pipes, constructed of 316L steel, corroded after three (3) months, the asset owner turned to NRI for a customized solution that could keep the plant in operation until the next scheduled shutdown.

Designed for the transportation of condensate, the line's working temperature can exceed 158°F (70°C). Inspection revealed leaks, as well as corrosion defects and cracks. These issues needed to be immediately addressed.

Following the inspection and, a technical evaluation by NRI's engineering staff, a composite system solution to repair and reinforce the pipe was agreed upon. First, crews performed surface prep by removing surface contamination through grinding and degreasing. Next, any voids in the metal were filled with Thermo-Fill™ HT, a titanium-reinforced, two-part epoxy compound. This was followed by an application of twelve (12) layers of Thermo-Wrap™ composite on all compromised straight pipe, elbows, tees, and welded joints.

The composite installation was performed without incident and the line continued operating safely during the repairs. An inspection conducted three (3) months after the work confirmed that the system was in good working order. A six (6)-month inspection has shown that the installation is still in safe operating conditions. The asset owner is extremely pleased with the outcome, and looks forward to utilizing NRI composites and NRI engineering for future projects.
