TRIDENT-SEAL®

3" OD VALVE REPAIR: NATURAL GAS, USA

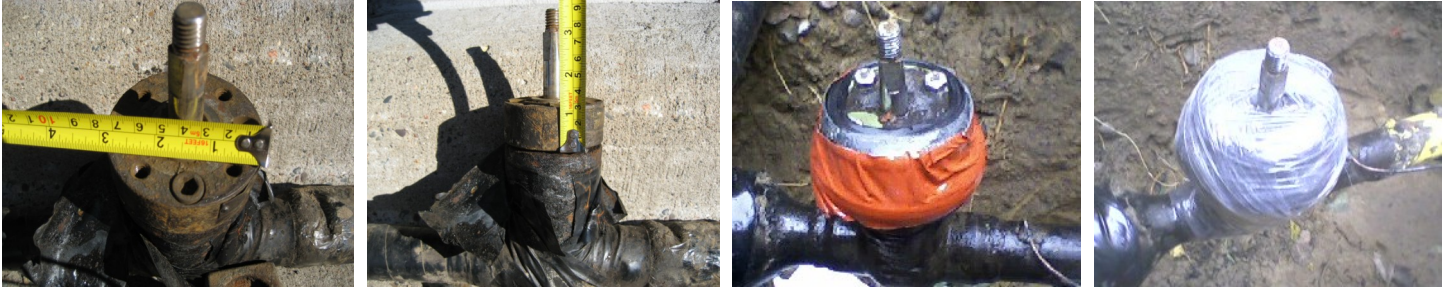
An in service natural gas distribution valve located in a remote country side setting was damaged during a service repair. The result of the damage was a small fuzz leak that was migrating around the flange and one of the bolts.

The origin of the leak was verified and a Trident-Seal® repair kit was pulled from the service truck. The valve was cleaned by removing rust, paint, and other foreign matter to promote adhesion, with the pre-packed emery cloth and solvent cleaning wipe, components provided within the Trident-Seal kit. The operator qualified applicator applied the kneaded Trident-Seal Putty adjacent to the leak point then mechanically forced the putty into the leak point with the Trident-Seal Pressure Sealing Tape. The simplistic combination of these two materials allowed the gas utility to verify that the leak was sealed in less than 10 minutes from the start of the repair. After verifying that the leak had been stopped, the gas utility applied the water activated Trident-Glass™ outer wrap to permanently hold the repair system in place and add reinforcement to valve.

The Trident-Seal composite repair system eliminated the need to replace the valve. The repair, which could have taken a substantial amount of time and hundreds of dollars, was completed inexpensively in a matter of 30 minutes.
