# SYNTHO-GLASS®UP

## REFINERY 3" OD PRESSURIZED LEAK REPAIR

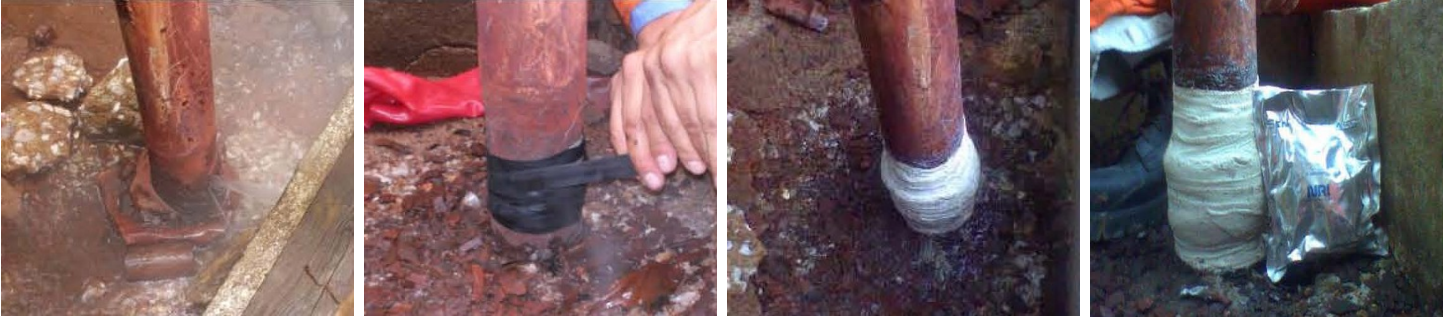
A refinery in Tula, Hidalgo Mexico located a pinhole leak on a 3.5" OD steel pipe.

The pipe is pressurized at 30 psi (2 bar), carrying water and oily condensate at 122°F (50°C), and cannot be shut down for repair.

The refinery simply used one Syntho-Glass®UP415 Kit to repair the leak. After preparing the surface using the included sanding cloth and solvent cleaning wipe, Syntho-Steel™ load transfer putty was applied to seal the leak and was held in place using Pressure Sealing Rubber Tape. Eight layers of Syntho-Glass® was then applied to strengthen the pipe and rebuild the pipe wall back to MAOP.

The repair was completed in less than 30 minutes without the need to shutdown, saving precious time and money.
