VIPER-SKIN™

12" OD CORROSION REPAIR, USA

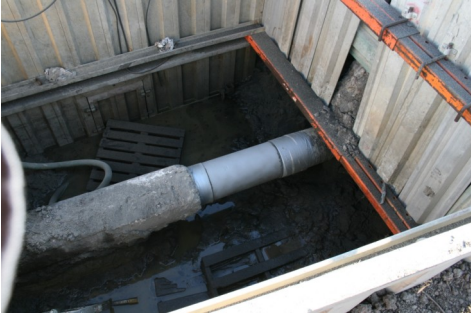
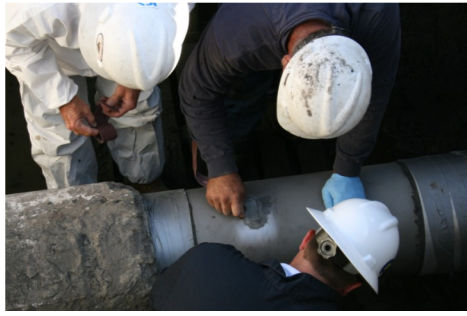
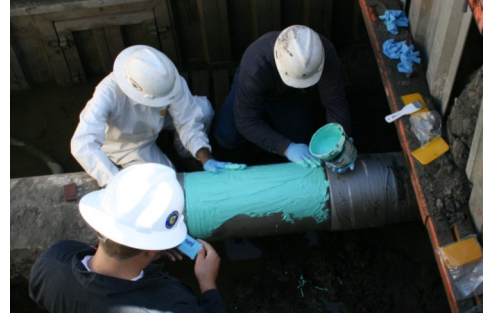
A 12" OD carbon steel pipe was experiencing external corrosion damage and pitting up to 80% wall loss. A repair was required in order to maintain the design pressure of the system at 1,465 psi (101 bar).

The section of the 1,465 psi (101 bar), 12" OD natural gas pipeline that was experiencing the pitting was located on a buried section of the pipe. The pitting occurred over a length of approximately 1' (30.5cm) of the pipe, which also had a concrete coating.

In order to promote adhesion to the pipe, the concrete coating was removed and the pipe was prepared in accordance with Sa2.5 or NACE 2. A 18,000 psi (1,241 bar) high compression strength filler called Syntho-Poxy™HC was used to fill the pits and form the pipe back to its original circumference. Thirty mils of Syntho-SubSea™LV epoxy was applied over the entire repair area to provide corrosion protective over the bare steel pipe, effectively locking out any atmospheric conditions from the surrounding environment. The Syntho-PoxyHC and Syntho-SubseaLV work together to transfer the hoop loading of the 1,465 psi (101 bar) carbon steel pipe into the high tensile strength of the Viper-Skin™ carbon fiber composite wrap, fully restoring the integrity of the pipeline.

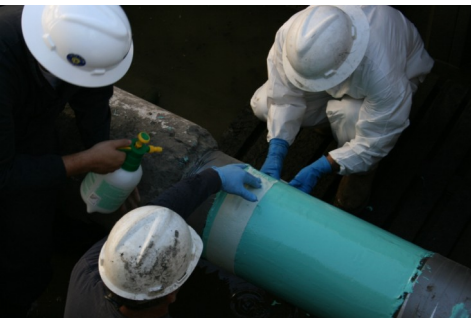
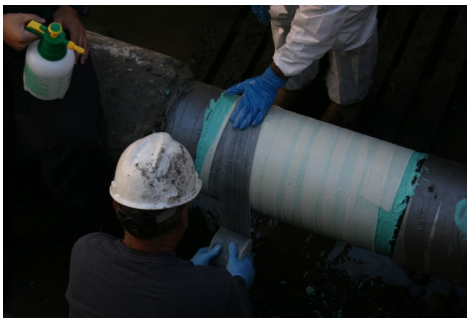
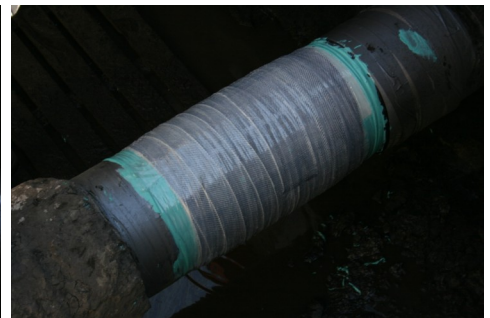
The Viper-Skin composite repair system eliminated the need to immediately replace the defective section of pipe. The entire repair was completed inexpensively in a matter of hours. Viper-Skin fully restored the pipe's strength to enable full pipeline operations.
