SYNTHO-GLASS[®] XT

46" OD PROCESS WATER LINE

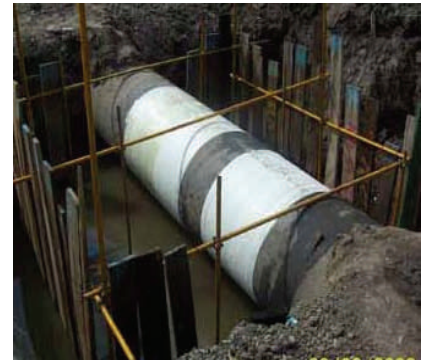
A 30 psi (2.07 bar), 46" OD process water line is leaking and in need of immediate repair.

Through wall leaks and cracks caused by internal and external corrosion.

In order to promote adhesion, the pipe was cleaned by removing rust, paint, and other foreign matter in accordance with Sa2.5, NACE 2 or near white metal. Syntho-Steel[™] Load Transfer Putty fills all pits, dents, and other anomalies, effectively transferring the hoop load to the high tensile strength composite. Syntho-SubSea[™]LV High Compression Kelvar[®] filled Epoxy ensures a water tight seal over the repair area while providing chemical resistance. Syntho-Glass[®] XT Extreme Tensile Strength Composite, a bi-directional fiberglass, permanently repairs and reinforces both the internal and external corrosion damage.

The composite repair system eliminated the need to immediately replace the line. The repair was completed inexpensively in a matter of hours. Syntho-Glass XT fully restored the pipe's hoop and axial strength to enable operation at full MAOP.
