# SYNTHO-GLASS<sup>®</sup> XT

## 14" OD INJECTION LINE, CANADA REINFORCEMENT AND REPAIR

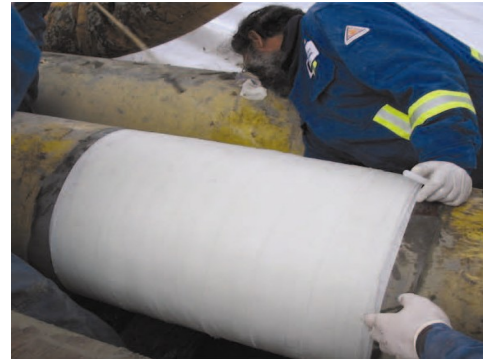
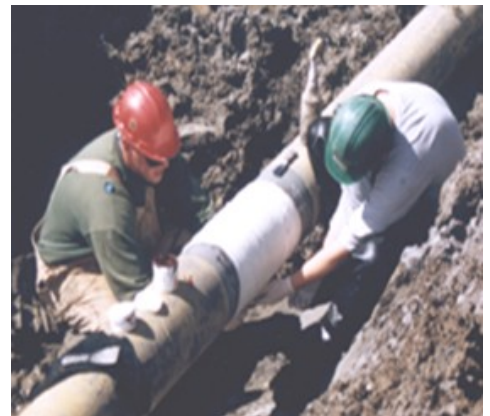
A 14" OD high pressure water injection line has external corrosion on girth welds due to corrosion under shrink sleeves.

Removal of the shrink sleeves revealed external corrosion ranging from 20% to 50% wall loss.

After sufficient surface preparation, Syntho-Steel<sup>™</sup> epoxy mastic was applied to the corroded area and then wrapped with the calculated number of layers of Syntho-Glass<sup>®</sup> XT. This solution brings the HPI line pressure capability back to that of a pristine pipe.

Thirty joints ultimately repaired with each, then subsequently pressure tested with no failure. Normal operations resumed at 2,300 psi (158 bar)
