## **Developing a Composite Repair System for High Temperature Pipe Repairs**

Matthew A. Green, Neptune Research, Inc.

### **Abstract**

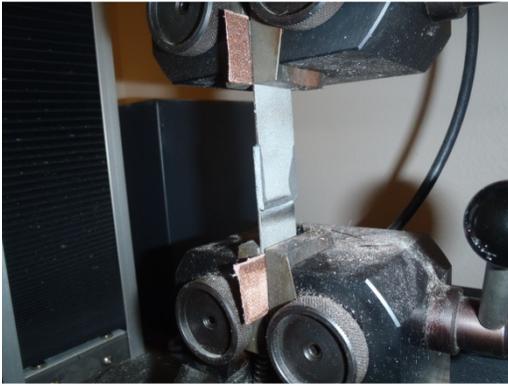
**Figure 5 - Tensile Coupon Test Setup**

strength of the system. Once created, two of the three panels were then placed into an oven to be temperature saturated for a period of seven days and for a period of 30 days. All panels were initially cured at room temperature. Prior to testing (but after removal from oven environment), each panel was then cut into the individual tensile coupons using a water jet cutting technique. By using the water jet technology, this creates a cleaner cut with less induced edge stress than using a different cutting method (such as traditional metal saw blades). (Figure 4) Initial tensile testing involved two different epoxy systems (Gen. A and Gen. B), and each were used for the initial layout at the room temperature cure panels. Subsequent testing in the high temperature environment focused only on the Gen. B epoxy system. All coupons were tested on a 10 ksi tensile testing machine to determine tensile strength, tensile modulus, and elongation. (Figure 5)
