IPC2012-90318

CATHODIC DISBONDMENT TESTING COMPARISON OF CARBON FIBER, FIBERGLASS, AND HYBRID COMPOSITE REPAIR SYSTEMS FOR PIPELINES

Neptune Research, Inc. (NRI)

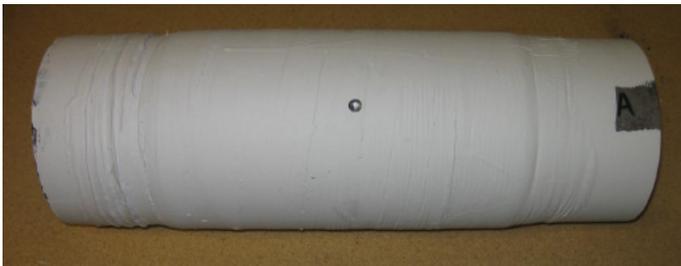
Once wrapped with the composite system, the entirety of the test specimen, including the composite, was coated with a standard epoxy coating to completely isolate the pipe from the solution except for the holidays created. The holidays were made in each pipe specimen using a 0.25" milling drill bit after wrapping and final epoxy coating. A hole was drilled through the coating and composite system and into the steel careful not to fully penetrate the wall thickness, but just to create a 0.25" diameter circle of bare steel as shown in Figure 1 below.

Figure 1 - Pipe specimen wrapped, coated, and holiday created

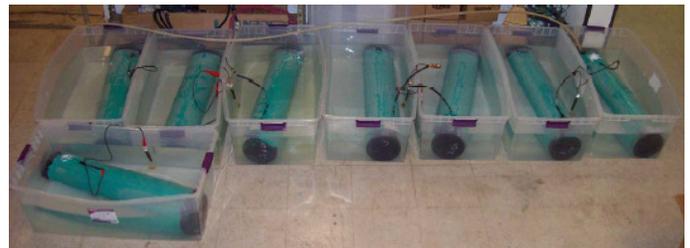
Once the pipe specimens were created and holidays drilled, each piece was placed into a plastic tub of salt water solution at room temperature (72° F / 22° C). The solution consisted of 1% mass of salts: sodium chloride, sodium sulfate and sodium carbonate, in order to create a corrosive environment in which to conduct the testing.

Figure 3 – Pipes submerged in corrosive solution
