OFFSHORE 24" OD RISER REPAIR PHILIPPINES, OCTOBER 2016

Project Overview

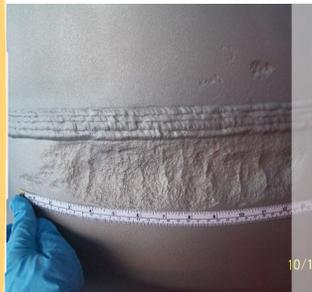
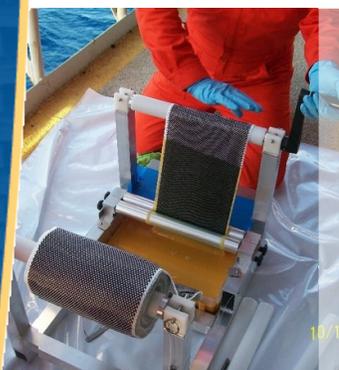
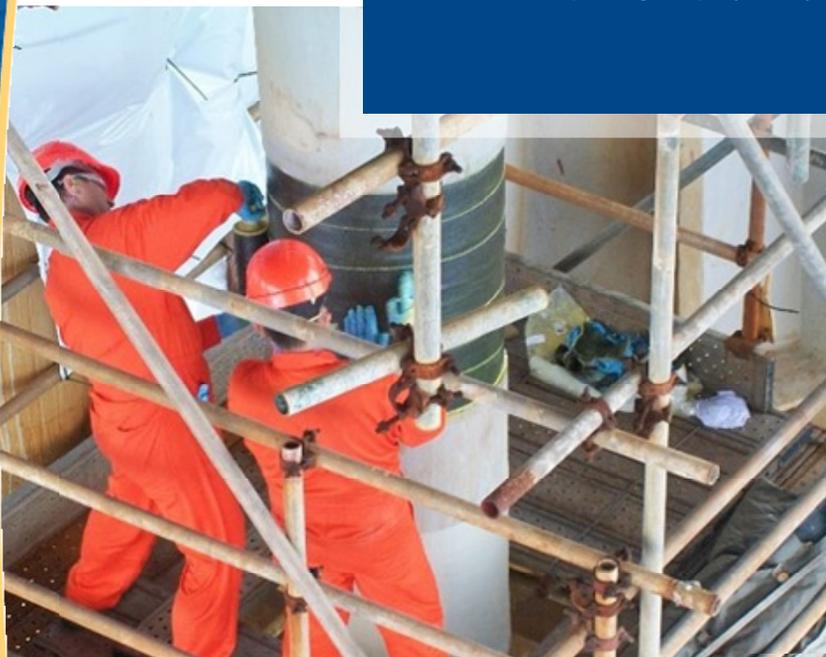
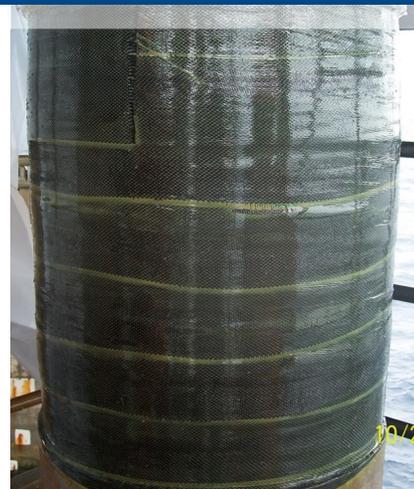
The repair areas were prepared in accordance with SSPC-SP10 / NACE 2 Near-White Blast Cleaning before the defects were filled using Thermo-Fill™HC, a high-compression strength liquid epoxy that provides a load transfer medium. Thermo-Poxy™ epoxy was then applied over the entire repair areas to provide corrosion protection to the bare steel, locking out any atmospheric conditions from the environment, while also acting as a primer for Thermo-Wrap™CF, a chemically resistant carbon fiber composite repair system, developed for high temperature applications. The carbon fiber composite system was field-saturated using NRI's Resinator™, then applied at the requested 12 layers over the repair lengths, fully restoring the integrity of the pipes. A jacket type of PFP was applied over the Thermo-Wrap CF system in order to fulfil the PFP requirement.

Two critical defects were repaired by an NRI-U led installation team in only 2 days. By utilizing Thermo-Wrap CF engineered composite repair system, the lines remained in full working operation without the need to reduce pressure, thereby fully repairing and reinforcing the sections while maintaining full function which saved the operating company money in associated shutdown costs of the platform.
