THERMO-WRAP™

INTERNAL THINNING – PIPE REHABILITATION

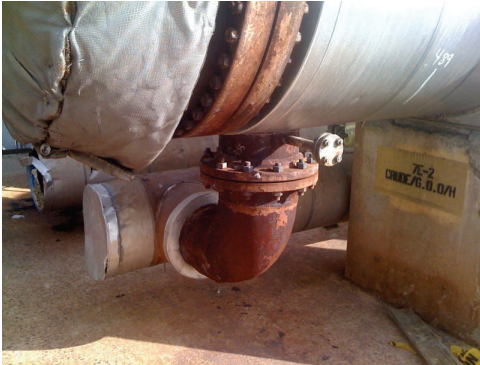
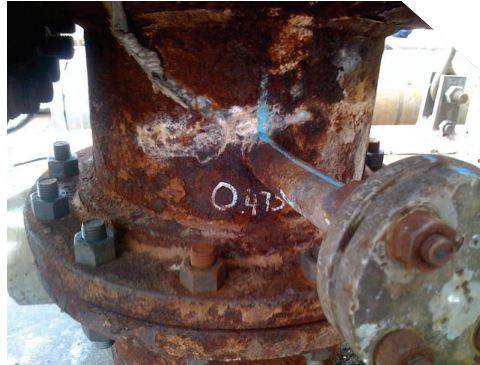
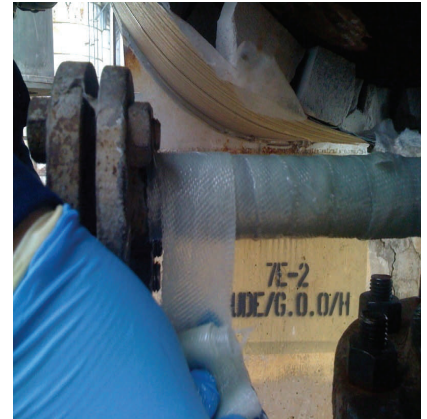
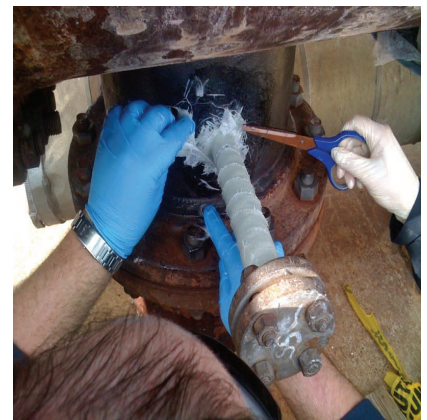
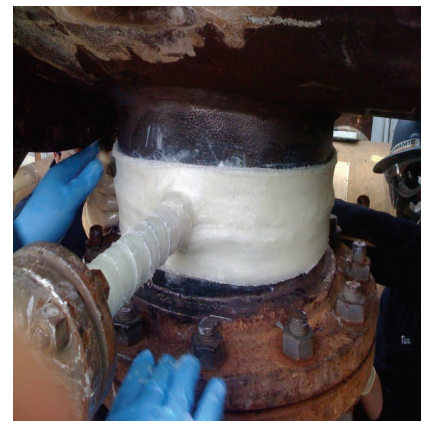
A number of 1.5" dead-leg nozzles with blind flanges branching off of a 12" main line carrying diesel fuel were experiencing internal corrosion. The skin temperature of the pipe of approximately 375° F (190° C), in conjunction with the odd and difficult pipe geometry, was a limitation for the application of most standard repair methods. The pipe could not be shut down or reduced, so the repairs had to be made with the pipe in full operation.

With the presence of internal wall loss, a repair was required in order to sufficiently reinforce the thinned area to prevent failure and keep the system in working order. The live skin temperature of the pipe was elevated to a point that most repair systems do not work as expected and are difficult to apply. While the repair conditions were in excess of the standard working conditions of most composites, the repair was only needed for a brief time until the pipe could be replaced.

Thermo-Wrap™ is an E-glass fabric saturated with a proprietary epoxy blend to form a composite repair system that has been developed specifically for high temperature applications and environments. In order to promote adhesion, the pipe was cleaned by removing rust, paint, and other foreign matter using power tools. The two part epoxy was then applied to the prepared surface to promote bond and prevent corrosion. The section of pipe was then wrapped with the Thermo-Wrap system, a 100,000 psi (6,895 bar) tensile strength fiberglass wrap system, which provides structural integrity to the thinned pipe, now and into the future.

In only a few hours, NRI was able to fix this issue in 8 separate locations of the thinned pipe and restore it to higher than its original design pressure. By utilizing the Thermo-Wrap composite repair system, the pipe could remain in full working operation without the need to reduce the temperature or pressure, thereby fully repairing and reinforcing the section, while maintaining the current production schedules.
