SYNTHO-GLASS[®] XT

NATURAL GAS PIPELINE INSTALLATION

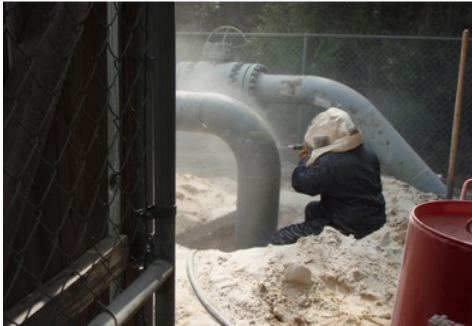
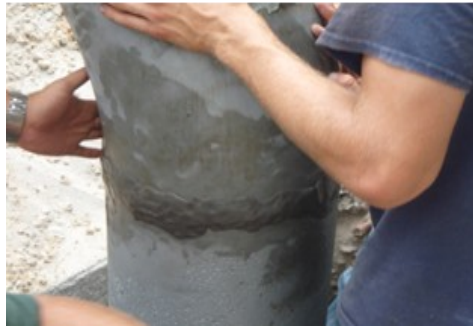
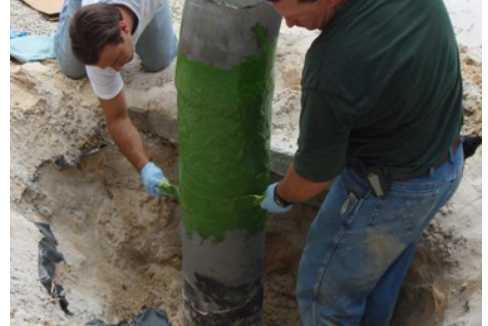
1275 psi (87.9 bar) carbon steel schedule 40 natural gas transmission line with 50% wall loss at the ground to air interface. Shutting down was not an option.

DOT regulated, high consequence natural gas pipeline located in a residential area next to an interstate highway.

In order to promote adhesion, the pipe was cleaned by removing rust, paint, and other foreign matter in accordance with Sa2.5, NACE 2 or near white metal.

Syntho-Steel[™] Load Transfer Putty fills all pits, dents, and other anomalies effectively transferring the hoop load to the high tensile strength composite.

Syntho-SubSea[™] High Compression Kelvar[®] filled Epoxy ensures a water tight seal over the repair area while providing chemical resistance.

Syntho-Glass[®] XT Extreme Tensile Strength Composite, a bi-directional fiberglass, permanently repairs and reinforces both the internal and external corrosion damage.

Syntho-Glass XT fully restored the pipe's hoop and axial strength to enable operation at full MAOP. Syntho-Glass XT saved thousands of natural gas home owners from being without service. The gas transmission company saved time, money and maintained good public relations. How can Syntho-Glass XT help you?
