TRIDENT-WRAP™

REPAIR KITS: RISER REPAIR AND REINFORCEMENT

Repair of non-leaking piping exhibiting pipe wall loss up to 80% at <300 PSI (20.7 BAR)

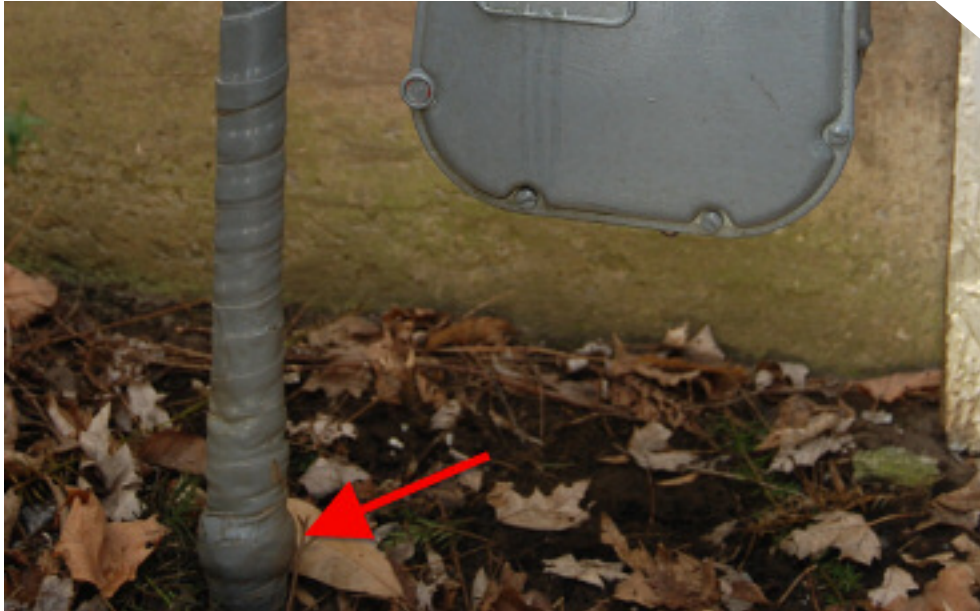
Trident-Wrap® Riser Repair and Reinforcement Kit is a composite repair system that enables one to repair corroded piping without shutdown or pipe replacement. This kit rebuilds damaged pipe wall and brings it back to original working pressure, while preventing future corrosion on steel, copper, PVC, ABS, and more.
