## UNCONVENTIONAL OPTIONS FOR RESTORING DEGRADING OR FAILING ASSETS

## Unconventional Options for Restoring Degrading or Failing Assets

*Matt Green, Neptune Research, Inc.*

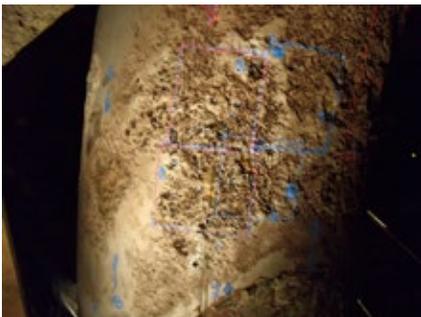
**Figure 1. Severe corrosion on 32 OD natural gas riser pipe.**

While this is a good example of how being proactive and using a great repair tool can be an effective means to prevent problems and reduce maintenance costs in the long run, there are times when situations are unavoidable and there is an immediate need. Let's go back to our initial discussion of the large diameter riser pipe. During the planning session, it was brought to the attention of the group that composite repair could be a viable option to repair and extend the life of the corroded natural gas export line. For this offshore exploration group, composite repairs had not yet been fully and formally introduced into practical field usage. After meeting with the engineering group and working with the manufacturer on the product testing, history, detailed design methods, and installation requirements, it was agreed that a composite repair was indeed the best way forward on this project.

The entire process for this project from evaluation to implementation was well documented by the government's power generation agency & the client's inspection team to ensure full compliance during all aspects of the installation. The composite repair system was successfully installed in 2009 returning this 32" OD, natural gas, export line back to its full test pressure rating of 1,960 psi (135 bar). Due to the critical nature of this specific project and the vital role of this pipe for the supply of natural gas to the region, the repair attracted much attention and was a featured story of CNBC.

A new in-line inspection of this pipe which was completed in 2012 revealed that no further corrosion has occurred in the repaired area. A follow up inspection of the composite repair indicated that it was also in excellent condition, and was therefore subsequently commissioned to remain in service until 2016 when another inspection will be completed, or the client chooses to fully replace the pipe section during a scheduled shutdown. It is currently still in successful operation today.

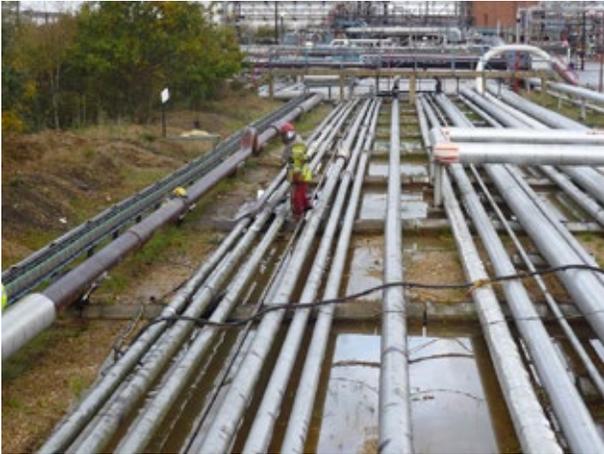
**Figure 2. Poorly designed pipe supports can cause corrosion and abrasion problems on the pipe.**

issue was with external corrosion at pipe supports. Within the approximately 50 year old facility, there are thousands of pipe supports with outdated design structures that were prone to experiencing crevice corrosion and abrasion.

A well-known composite repair system was fully vetted and duly qualified by the refinery staff for compliance with industry standards (the ASME PCC-2 and ISO/TS-24817), and the manufacturing company reviewed and audited for competency and quality certifications. After the full and detailed review and subsequent acceptance/approval, the facility set about repairing the corroded pipe support areas under a newly minted program called CAIR (Corrective Action Inspection Repair).

Beginning with the most heavily corroded pipes, the maintenance contractor has spent the last few years installing the composite repair system on the support areas to restore the pipe's original design parameters, as well as prevent future corrosion from occurring while keeping the piping systems in full operational status. This was a major action plan for the facility to undertake, but it has certainly paid off in a big way. Within the first two years, the maintenance and inspection departments have reported an 80% reduction in the number of leaks within the units that have implemented the CAIR program for composite repairs. This translates directly into a safer working environment and high operational savings for the plant, as it is much cheaper to perform proactive and preventative maintenance using composites early on in the pipe's operational life versus performing reactive maintenance when a leak occurs, requiring dangerous and costly repair methods that could result in a facility shutdown or other problems.

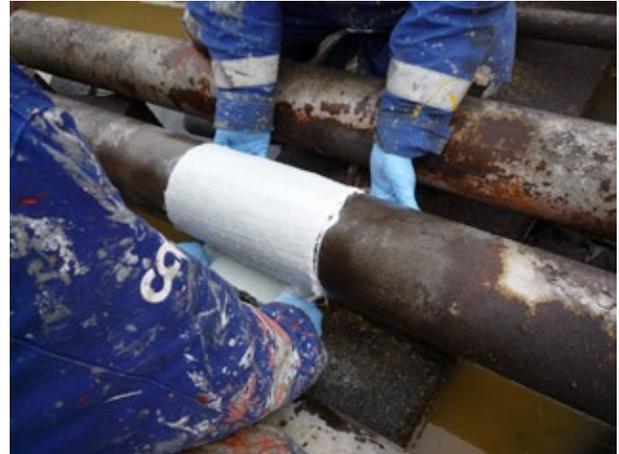
**Figure 3. Application of composite repair system for restoration and future protection.**

*“Within the first two years, the maintenance and inspection departments have reported an 80% reduction in the number of leaks within the units that have implemented the CAIR program for composite repairs.”*

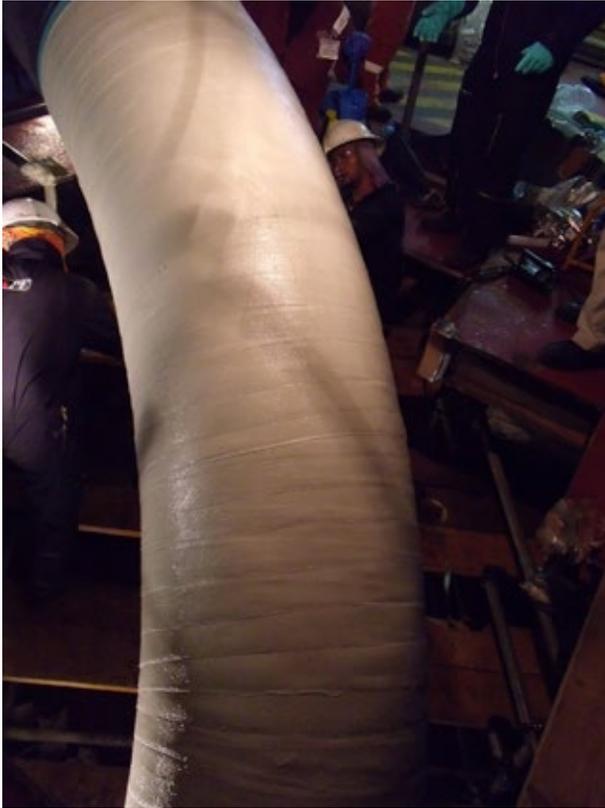
**Figure 4. Repairing of the 32" OD riser pipe over long rise and bend in pipe.**
