THERMO-WRAP™ 24 HDD

26" CRUDE PIPELINE CONSTRUCTION, SAUDI ARABIA
HDD - HORIZONTAL DIRECTIONAL DRILLING

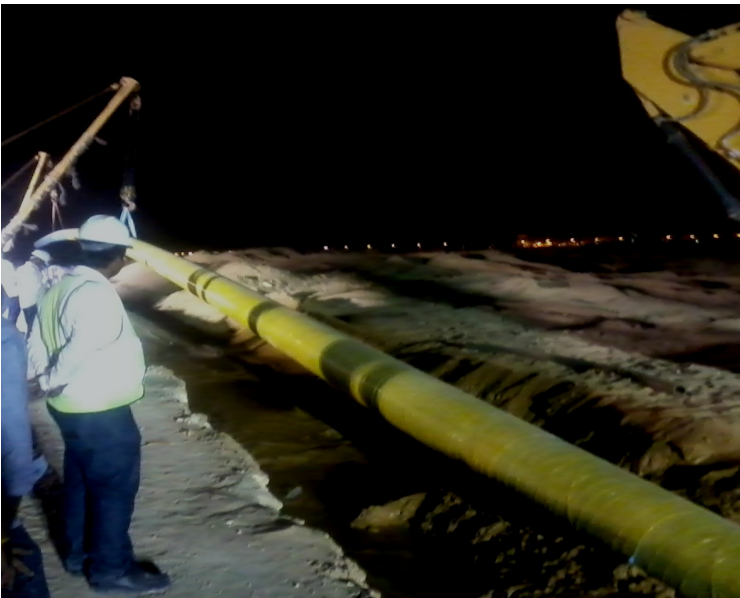
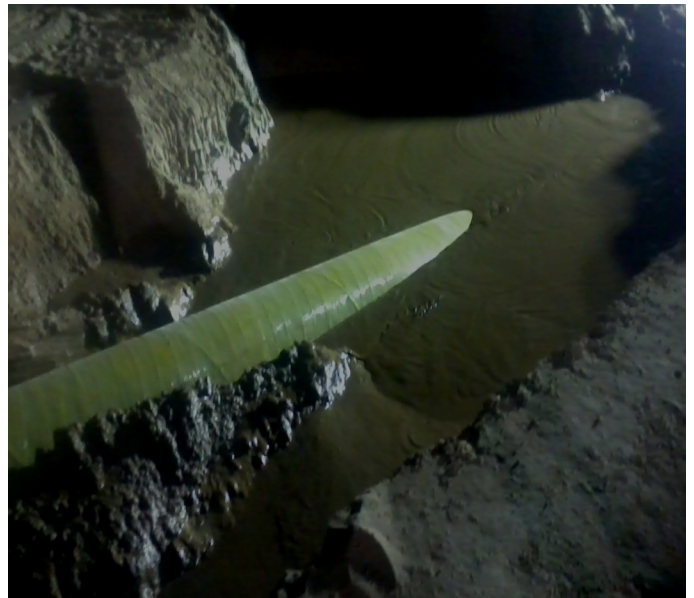
The Thermo-Wrap™24 HDD System was installed prior to the pull back of the 26" OD pipeline to protect the factory-applied FBE coating and girth-welded, field joints from the abrasion stresses and scarring associated with the horizontal directional drilling process. The Thermo-Wrap 24 HDD system provides mechanical protection to the approved, manufacturer-applied, FBE corrosion coating resulting in a very low profile, extremely conformable and highly impact resistant outer sleeve which protects the entire length of new pipe during the harsh pull back process.

The contractor on the project successfully installed the Thermo-Wrap 24 HDD system over 160 linear feet (49m) of 26" diameter pipe ahead of schedule, resulting in a cost-effective solution while insuring the integrity of the underlying FBE coating. The project was a great success and neither the pipe nor the original coating was damaged during the HDD pull back process.
