# VIPER-SKIN™

## 10" OD REPAIR AND REINFORCEMENT, PERU

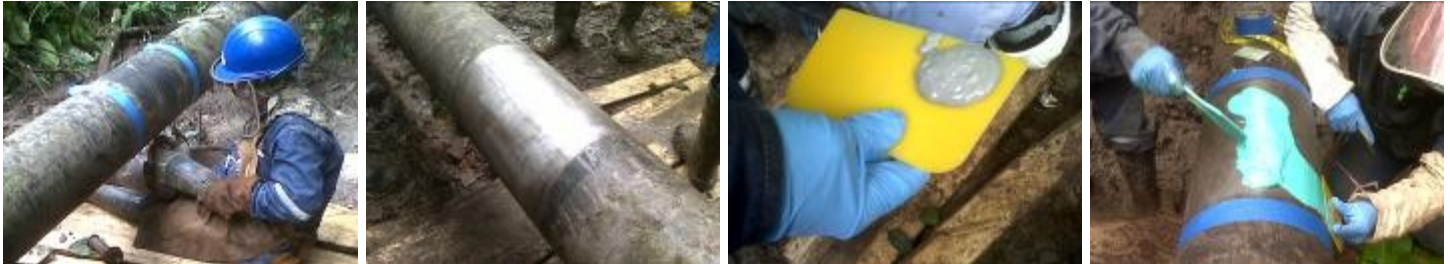
A 10" OD carbon steel pipeline operating at 200 psi (14 bar), with a test pressure of 1,260 psi (87 bar), was located in the Amazon Rainforest of Peru and was experiencing 79% wall loss in several locations. The petroleum company required an immediate solution that could be effectively and easily installed in the rainforest to prevent an unexpected shutdown or catastrophic rupture in the pipeline.

In order to promote adhesion, the pipe was cleaned by removing rust, paint, and foreign matter in accordance with Sa2.5 or NACE 2. Syntho-Poxy™HC, an 8,000 psi (552 bar) high compression strength filler, was used to reconfigure the pitted pipe back to its original geometry before 30 mils of Syntho-SubSea™LV epoxy was applied over the entire circumference to provide corrosion protection over the bare steel, effectively locking out any atmospheric conditions from the surrounding rainforest. The Syntho-PoxyHC and Syntho-SubSeaLV work in unison to transfer the hoop load of the 200 psi (14 bar) carbon steel pipe into the high tensile strength of the Viper-Skin™ carbon fiber composite wrap, fully restoring the integrity of the pipeline.

The Viper-Skin composite repair system eliminated the need to replace the defective sections of pipe, fully restored the pipe's hoop and axial strength enabling full pipeline operations and was completed cost effectively in only hours.
