SYNTHO-GLOSS[®]XT

6" OD REPAIR: POWER GENERATION, USA

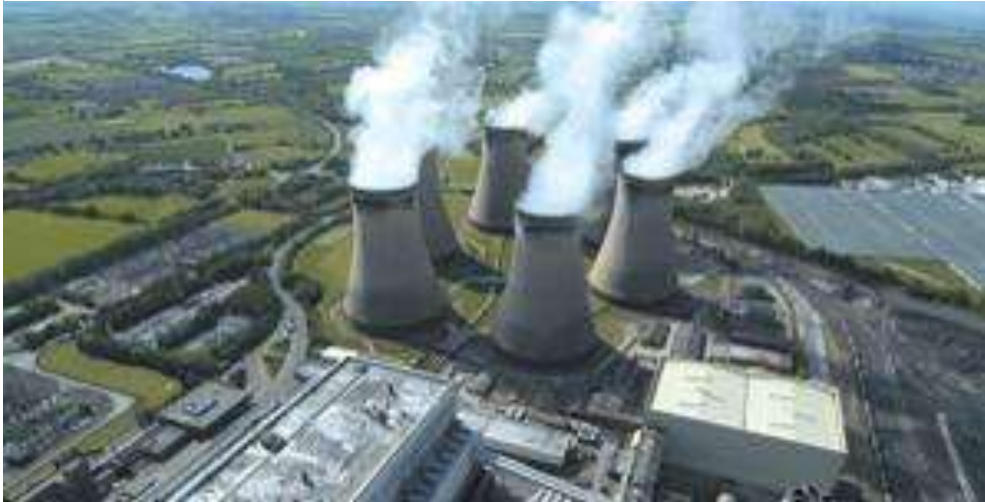
420" (10.67 meter) of the 6" OD carbon steel schedule API-5L Grade B line was displaying external corrosion due to heavy condensation.

The line carries water for the power plant's fire system; therefore long term shutdown was not an option.

In order to promote adhesion, the pipe was cleaned by removing rust, paint, and other foreign matter using power tools. It was then coated with Syntho-SubSea[™], a high compression strength two-part Kevlar[®] reinforced epoxy. The two-part epoxy stopped the corrosion and provided a load transfer median engineered to cycle and work with the 180 psi (12.4 bar) line. The line was then wrapped with 8 layers of Syntho-Glass[®]XT, a 54,000 psi (3723 bar) tensile strength fiberglass composite sleeve, which provides structural integrity to the repair.

This cost effective solution was an immediate success, as the line could not be taken out of service for more than one hour, which left it available in case of a fire. The line now has even more strength than the original pipe at the time of installation. The pipe once again meets the MAOP and is also protected from further corrosion.
