SYNTHO-GLASS® XT

32" TO 5" OD NATURAL GAS TEE, AMSTERDAM REINFORCEMENT AND REPAIR

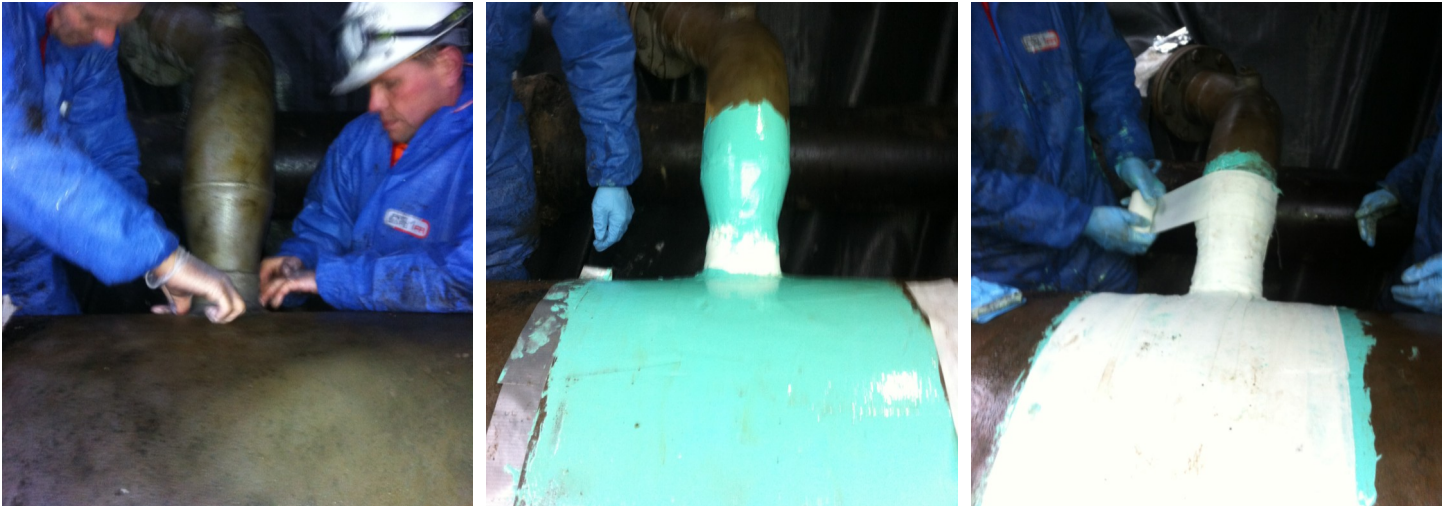
The welded joint connecting the 32" OD line to the 5" OD branch was leaking and in need of immediate repair.

The surface of the pipe was prepared by sandblasting in accordance with Sa2.5, NACE 2, or near white metal, to remove rust, paint, and any foreign matter to promote adhesion. Syntho-Steel™ load transfer putty was used to seal the leak and fill any corrosion pits on the pipe. The entire repair area was coated with 30 mils of an anticorrosion, adhesion promoting and load transferring epoxy, Syntho-SubSea™LV. The two-part epoxy effectively stops any future corrosion from forming while also providing a load transfer median engineered to cycle and work with the 45 psi (1 bar) design pressure of the pipeline. The entire repair length was wrapped with 8 layers of Syntho-Glass®XT, a 54,000 psi (3723 bar) tensile strength fiberglass composite sleeve.

The two man crew successfully installed Syntho-Glass XT system within 2 hours, effectively sealing the leak and restoring the structural integrity of the pipeline.
