SYNTHO-GLOSS[®] XT

20" OD UNDERGROUND PIPELINE INSTALLATION: REINFORCEMENT AND REPAIR

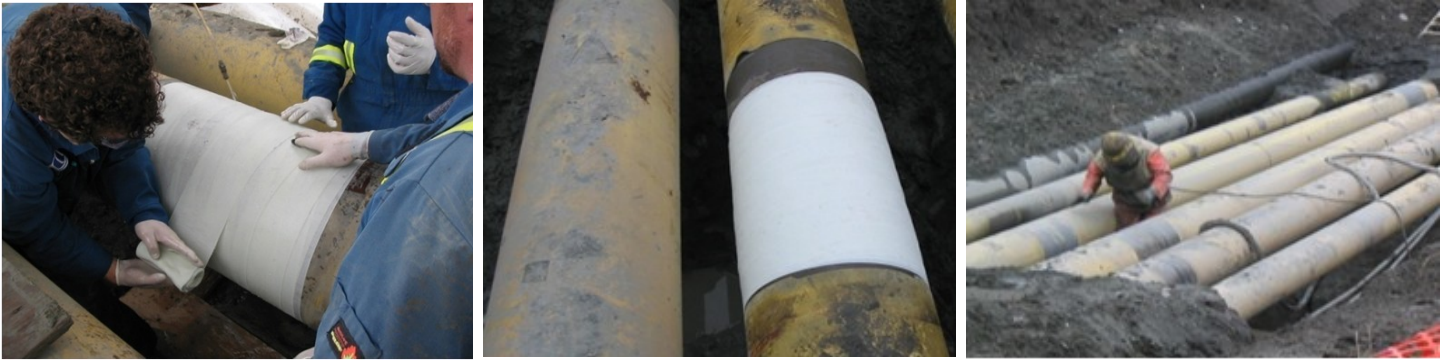
Numerous underground pipelines, with external wall loss and corrosion, are in need of immediate repair. Shutdown of the lines was not an option during repair and retrofit of the pipeline. A refineries' loading pipe lines were found to have multiple sections of external wall loss in excess of 50% in some areas of localized pitting.

The pipelines are unearthed to show multiple areas of corrosion damage and external wall loss. The pipes are old, still in workable condition, but in need of immediate repair and reinforcement.

The pipeline problem areas are first prepared by sandblasting, then applying an epoxy filler to fill in the pits with a secondary coat of a mastic epoxy to give added reinforcement and prevent future corrosion. These areas were then wrapped with multiple layers of Syntho-Gloss[®] XT to provide reinforcement, rebuild the pipe wall, and permanently repair the pipe.

The reinforced pipelines are brought back to their original strength with a permanent repair of their problem areas. The repair was completed without the need to shut down pressure through the lines, thus saving the customer hundreds of thousands in shutdown costs.
